Aquatic Resources Study Report

Bad Creek Pumped Storage Project

Oconee County, South Carolina

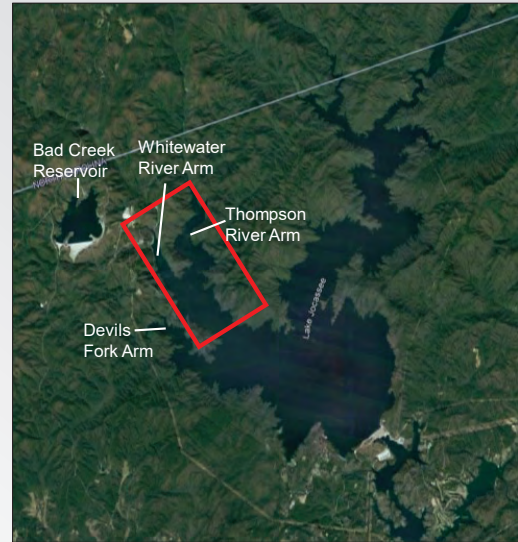
Take home message: Of the “bookend” scenarios analyzed, combined Bad Creek and Bad Creek II operations (39,200 cfs) with Lake Jocassee at minimum pond elevation (1,080 ft msl) was found to have the greatest effect on Whitewater River Cove hydraulics, however at the downstream model boundary that effect was negligible.

Lake Jocassee Area (full pond): 7,980 acres
Modeled Area (full pond): 2,840 acres
