Recreational Resources Final Study Report

Bad Creek Pumped Storage Project

Oconee County, South Carolina

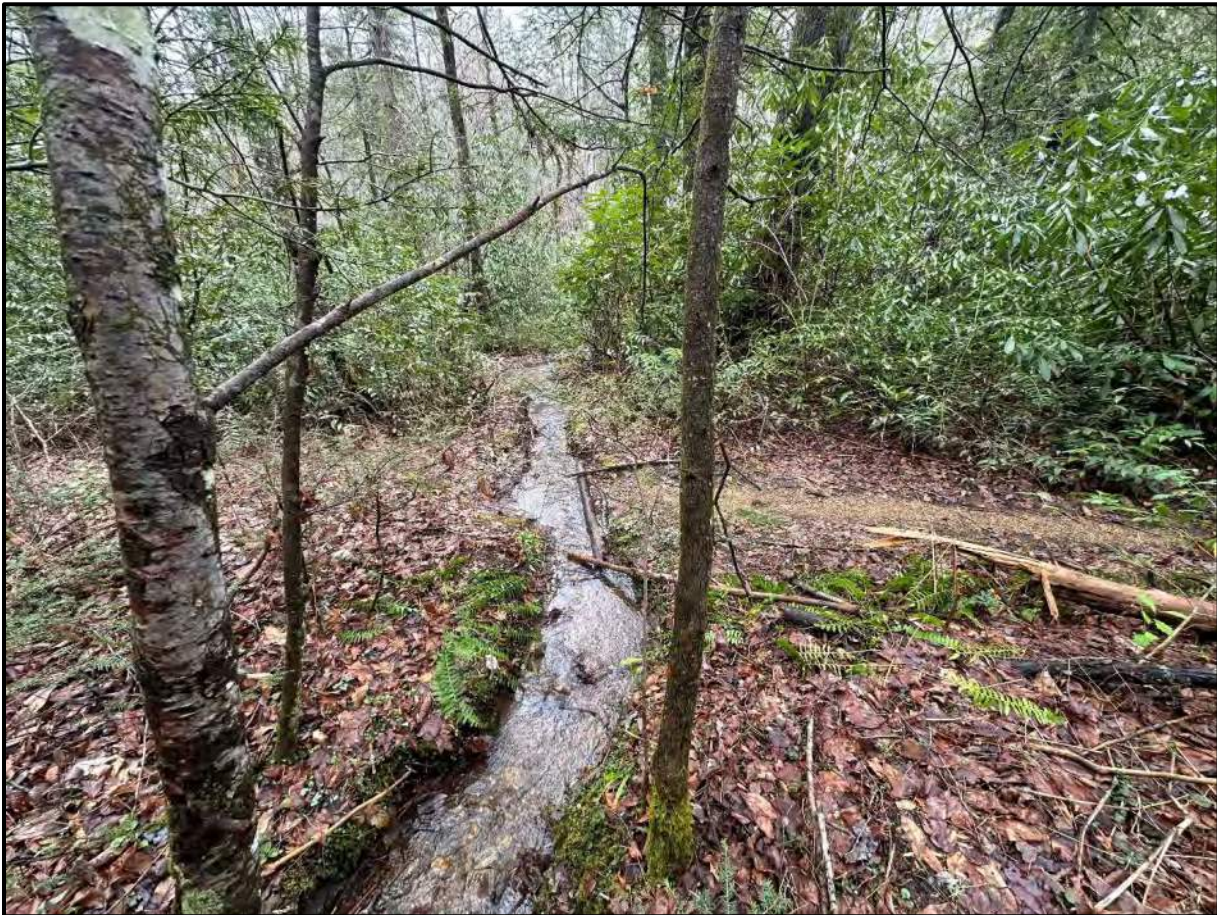
Photo 2 Trail Issue #11 – Existing Drainage

LCT revisited the location of Trail Issue 11 and noted that the existing narrow drainage ditch accommodates most rainfall or run-off (Photo 2). However, large rain events cause the ditch to overflow and wash over the trail. Photo 3 shows the downhill side of the trail and the drainage ditch. LCT noted that damage to the trail could occur over time if not addressed and recommends installation of a 12-inch culvert to capture water before it reaches the trail, and installation of a grade dip below the culvert on the downhill side of the trail. The grade dip would subvert any water that does get on the trail before it travels further and creates significant damage.

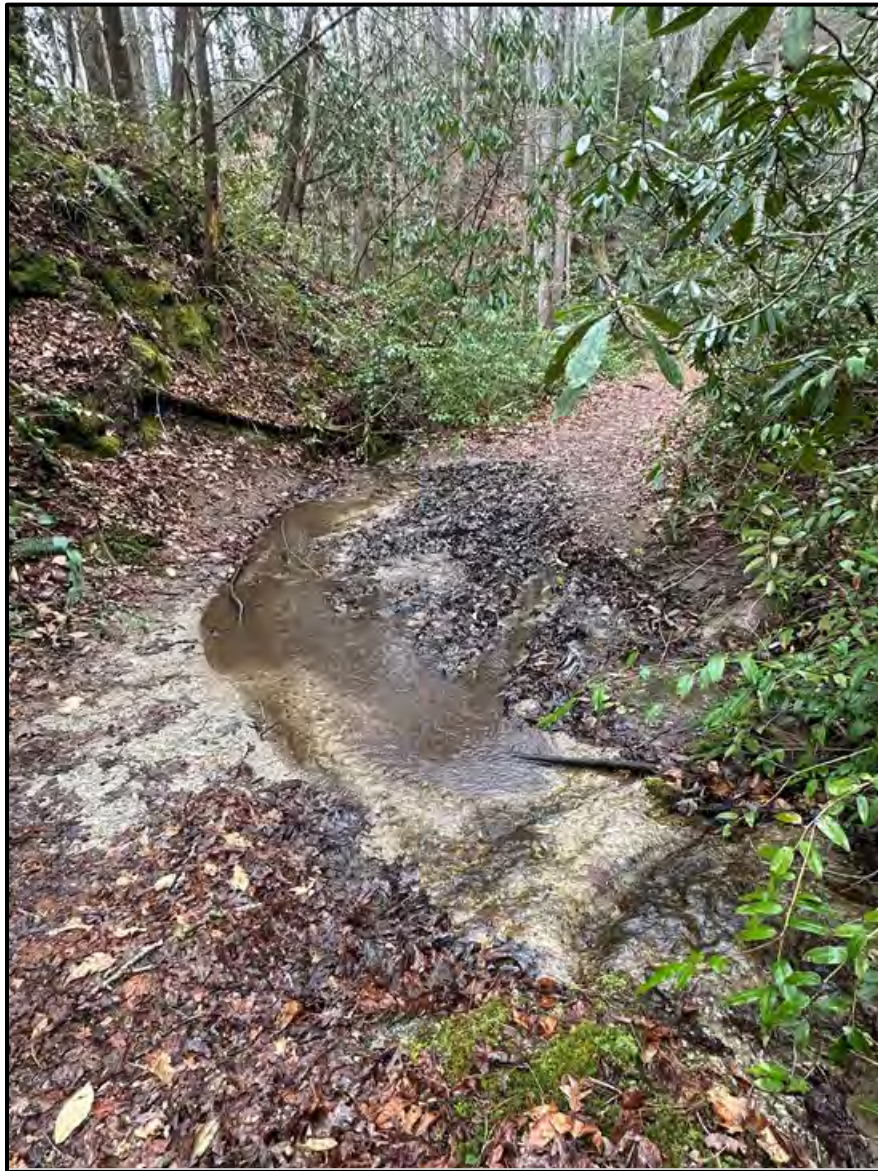
Photo 4 Trail Issue #58 – Washed-Out Trail

LCT revisited the location of Trail Issue 58 and determined that there was no existing culvert at the location (Photo 4). Since the initial inspection, a large rain event had caused the hole in the trail corridor to cave in and the surrounding sediment to wash away, creating a widened channel crossing the trail. LCT recommends installation of a 12-inch culvert at the site to focus the water across the trail and prevent future erosion.

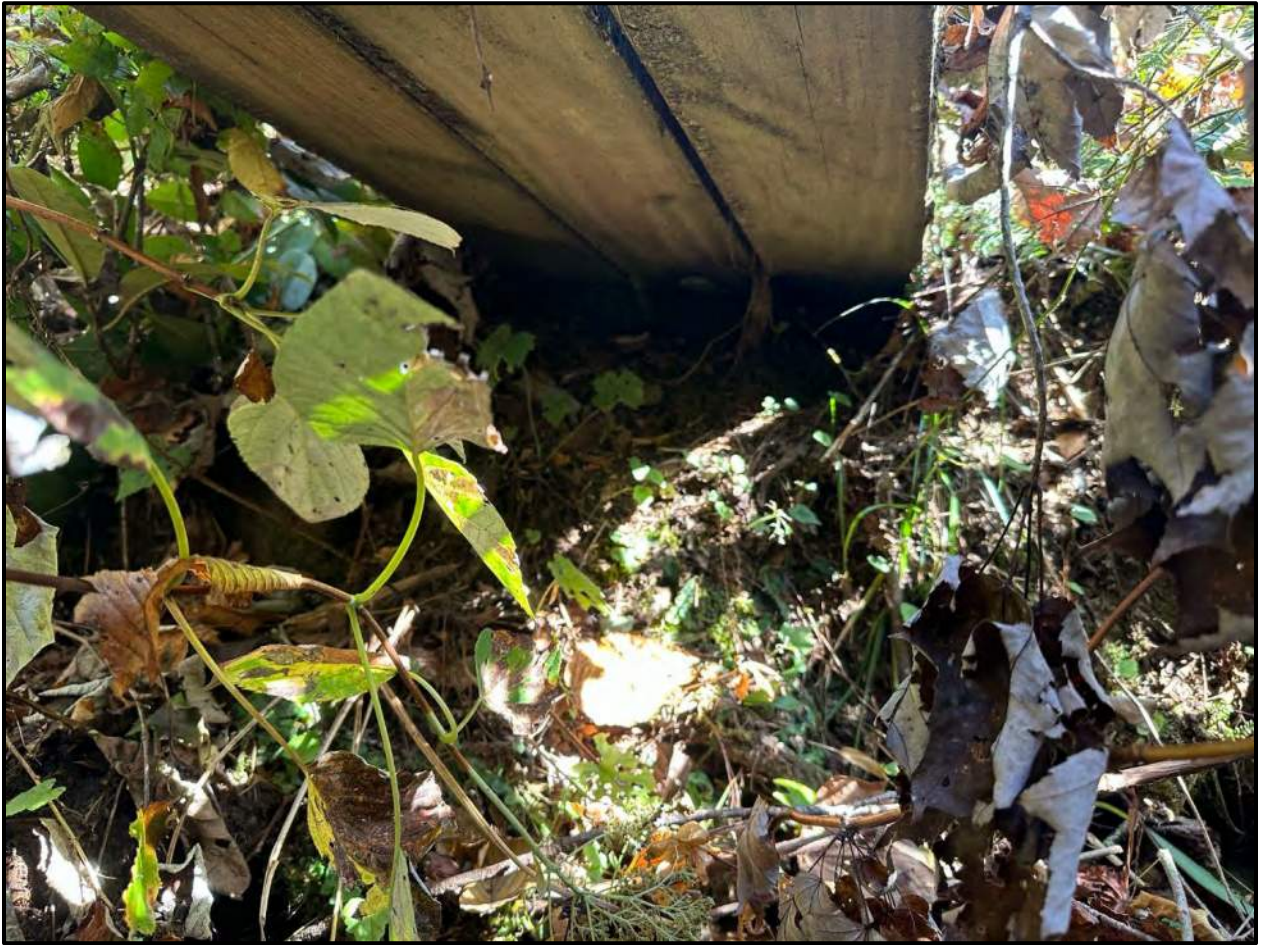
Photo 5 FTC 21 – Bridge Overlap with Trail

LCT visited the FTC 21 site to determine if there were signs of bank undercutting in late October 2024. Approximately one month earlier, on September 27, 2024, Hurricane Helene passed through the area causing significant flooding and wind damage. At the time of LCT's visit, signs of undercutting were observed (Photo 5), and the bridge was covered with fallen trees and debris (Photos 6 and 7). LCT recommends replacing the existing bridge's boards, which are 12 feet in length, with 14-foot boards to address the undercutting on each side. Additionally, since the bridge is approximately 3-feet high, LTC recommends adding handrails to the bridge. at the time of reconstruction.
