Subject: **Bad Creek Pumped Storage Project (P-2740-053)
Relicensing Study Progress Report No. 4**

Duke Energy Carolinas, LLC (Duke Energy or Licensee) is the Licensee, owner, and operator of the 1,400-megawatt (MW) Bad Creek Pumped Storage Project (FERC Project No. 2740) (Project), located in Oconee County, South Carolina, approximately eight miles north of Salem. The Bad Creek Reservoir (or upper reservoir) was formed from the damming of Bad Creek and West Bad Creek and serves as the Project's upper reservoir. Lake Jocassee serves as the lower reservoir and is licensed separately as part of Duke Energy's Keowee-Toxaway Hydroelectric Project (FERC Project No. 2503).

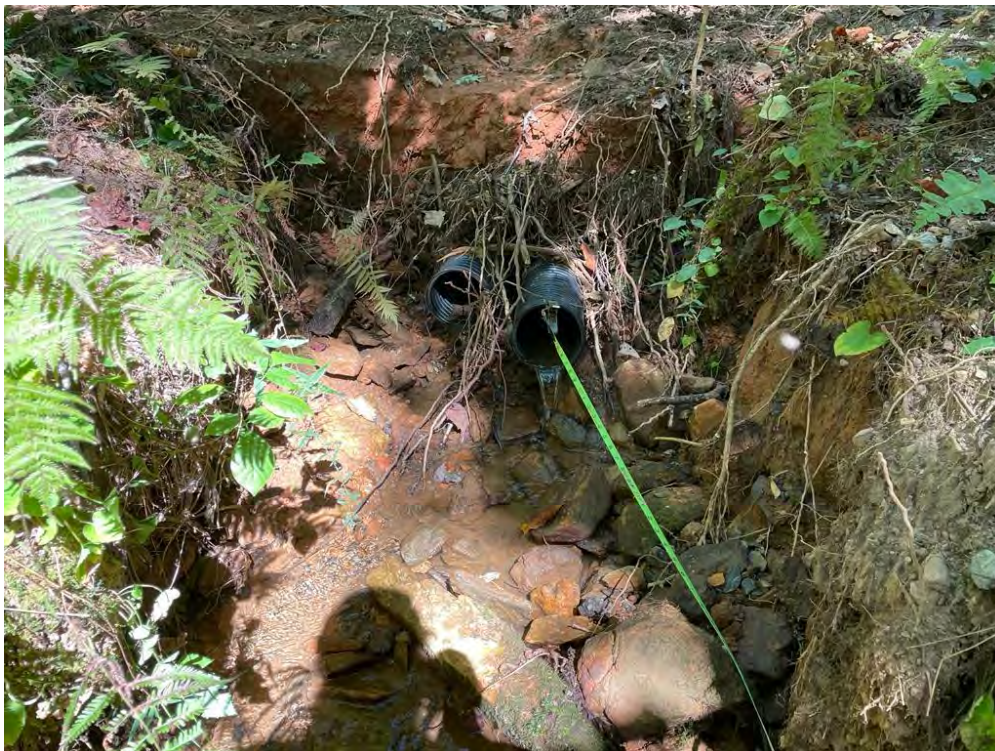
Photo 12. View of concentrated flow point on Stream 16, beginning of downstream reach.
