Bad Creek Revised
Study Plan Appendices
Part III
Appendix I

SUPPLEMENTAL INFORMATION – GEOLOGY AND PROJECT FEASIBILITY

**Bad Creek Pumped Storage Project
FERC Project No. 2740**

Oconee County, South Carolina

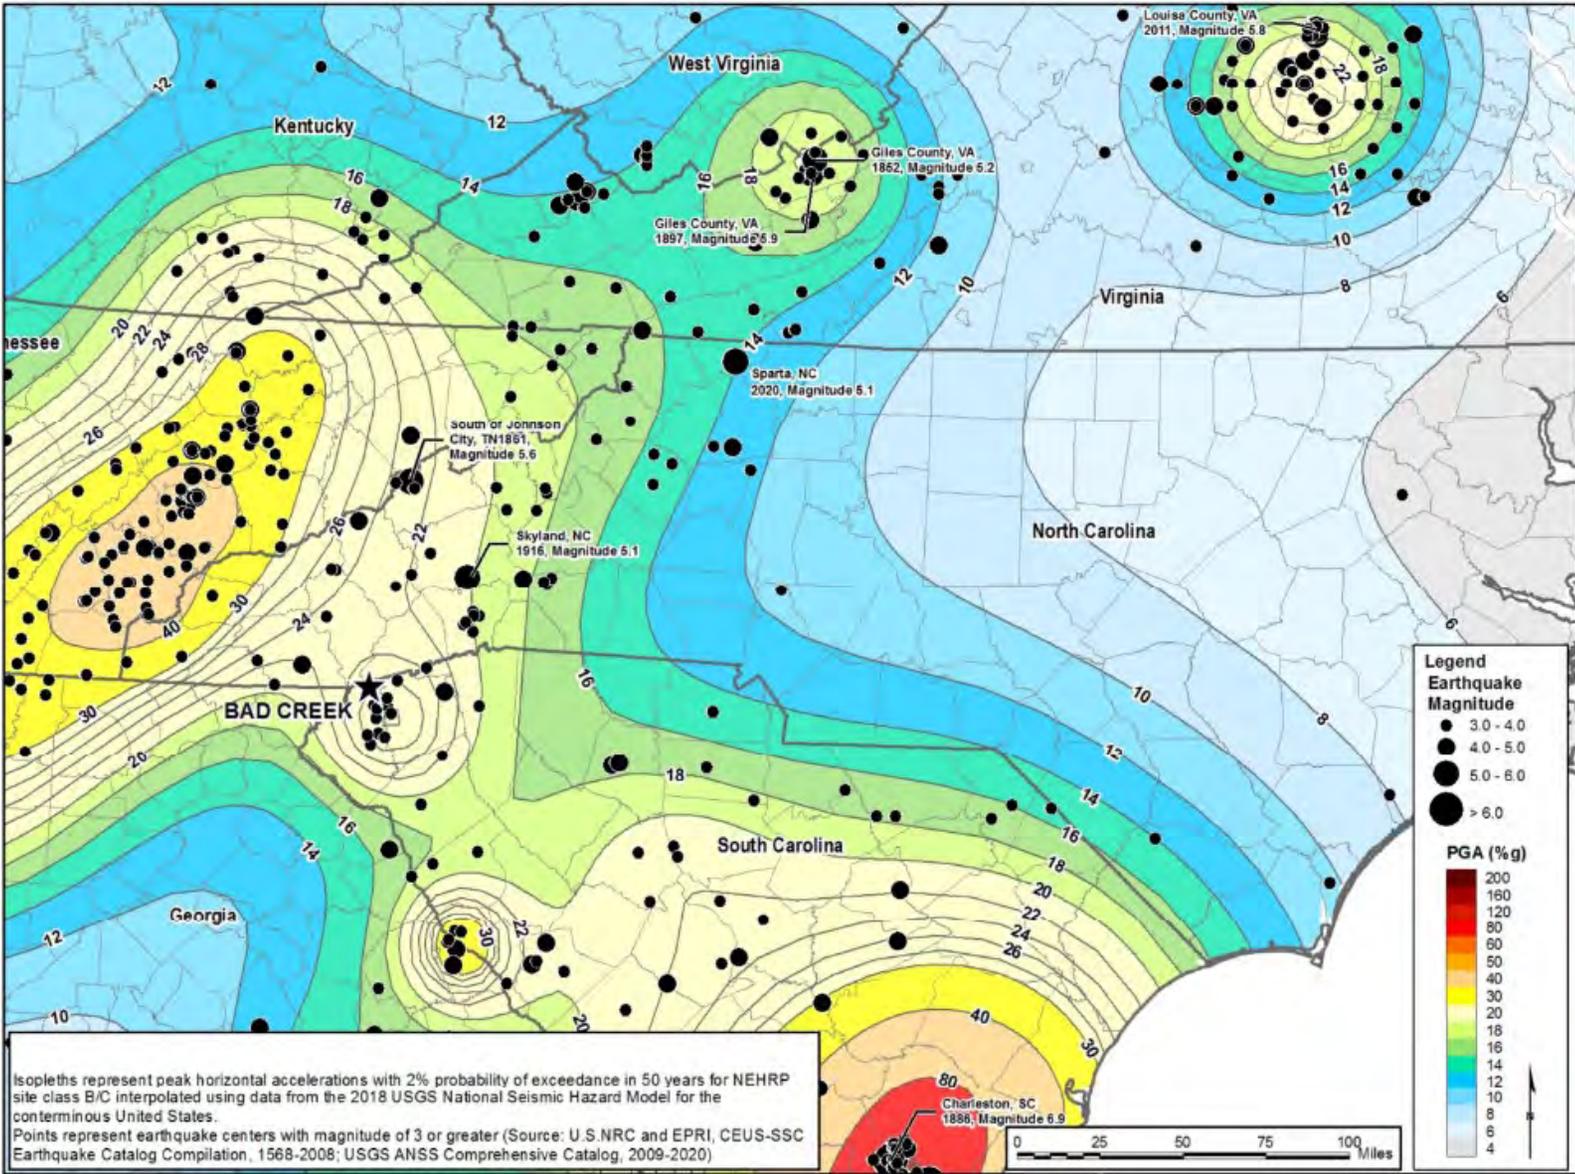
Earthquakes with $M_w \geq 3$ and contours of Peak Ground Acceleration (PGA) for V_{s30} ³ equals 760 m/sec with 2 percent probability of exceedance in 50 years (2475-year return period) from the 2018 National Seismic Hazard Maps developed by the U.S. Geological Survey (USGS 2018) are shown on Figure 3-6. The PGA at the Bad Creek Project site is 0.24g for V_{s30} of 760 m/sec (Site Class B/C⁴ Boundary) and 0.21g for V_{s30} of 2000 m/sec (Site Class A⁴) as shown in Figure 3-7 as are the hazard curves for spectral acceleration at selected periods and a Uniform Hazard Spectrum (UHS at 5% Damping) for both values of V_{s30} (USGS 2014b).

Figure 3-6. Seismic Hazard and Historic Earthquake Centers near the Bad Creek Pumped Storage Project

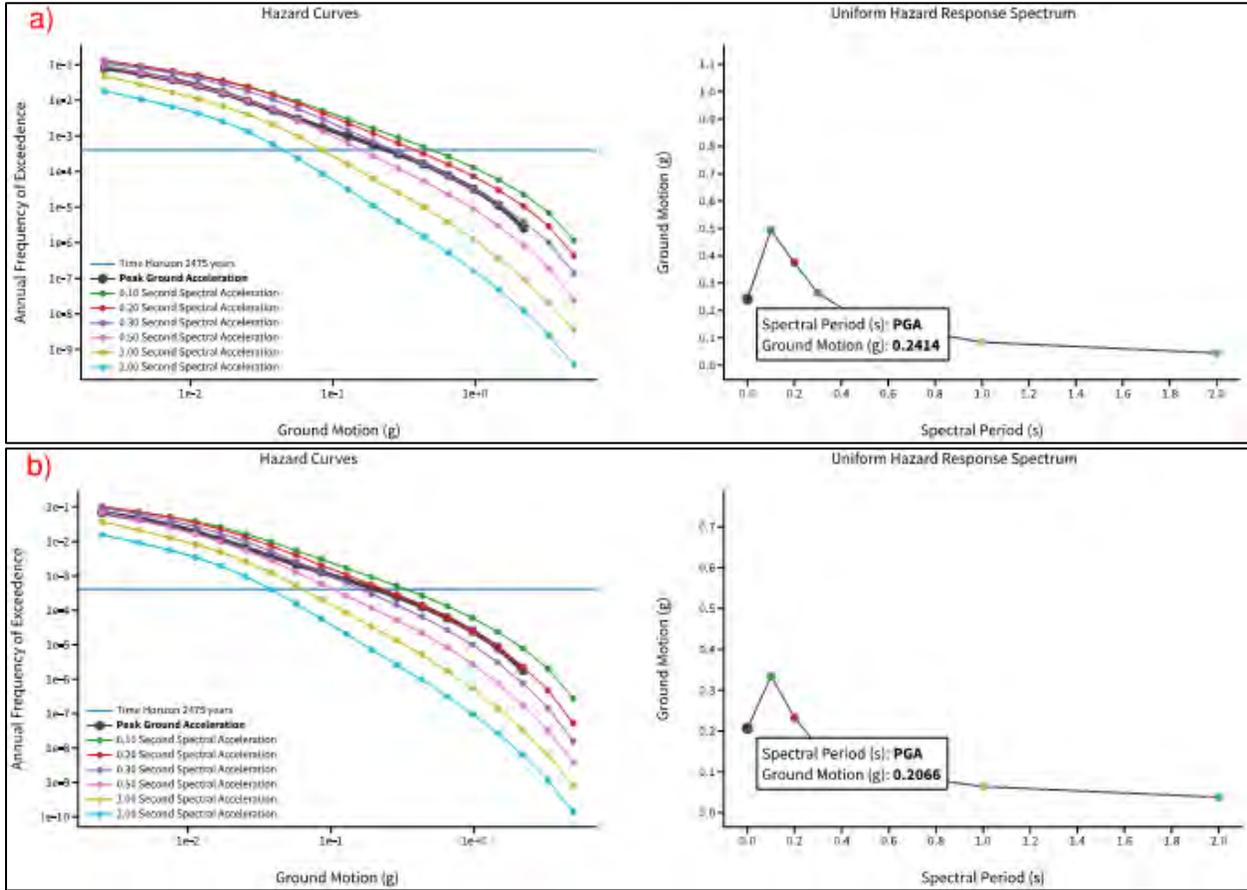
Figure 3-7. Hazard Curve and Uniform Hazard Response Spectrum (2475-year return period; 5% Damping) for a) $V_{s30} = 760$ m/sec and b) $V_{s30} = 2000$ m/sec

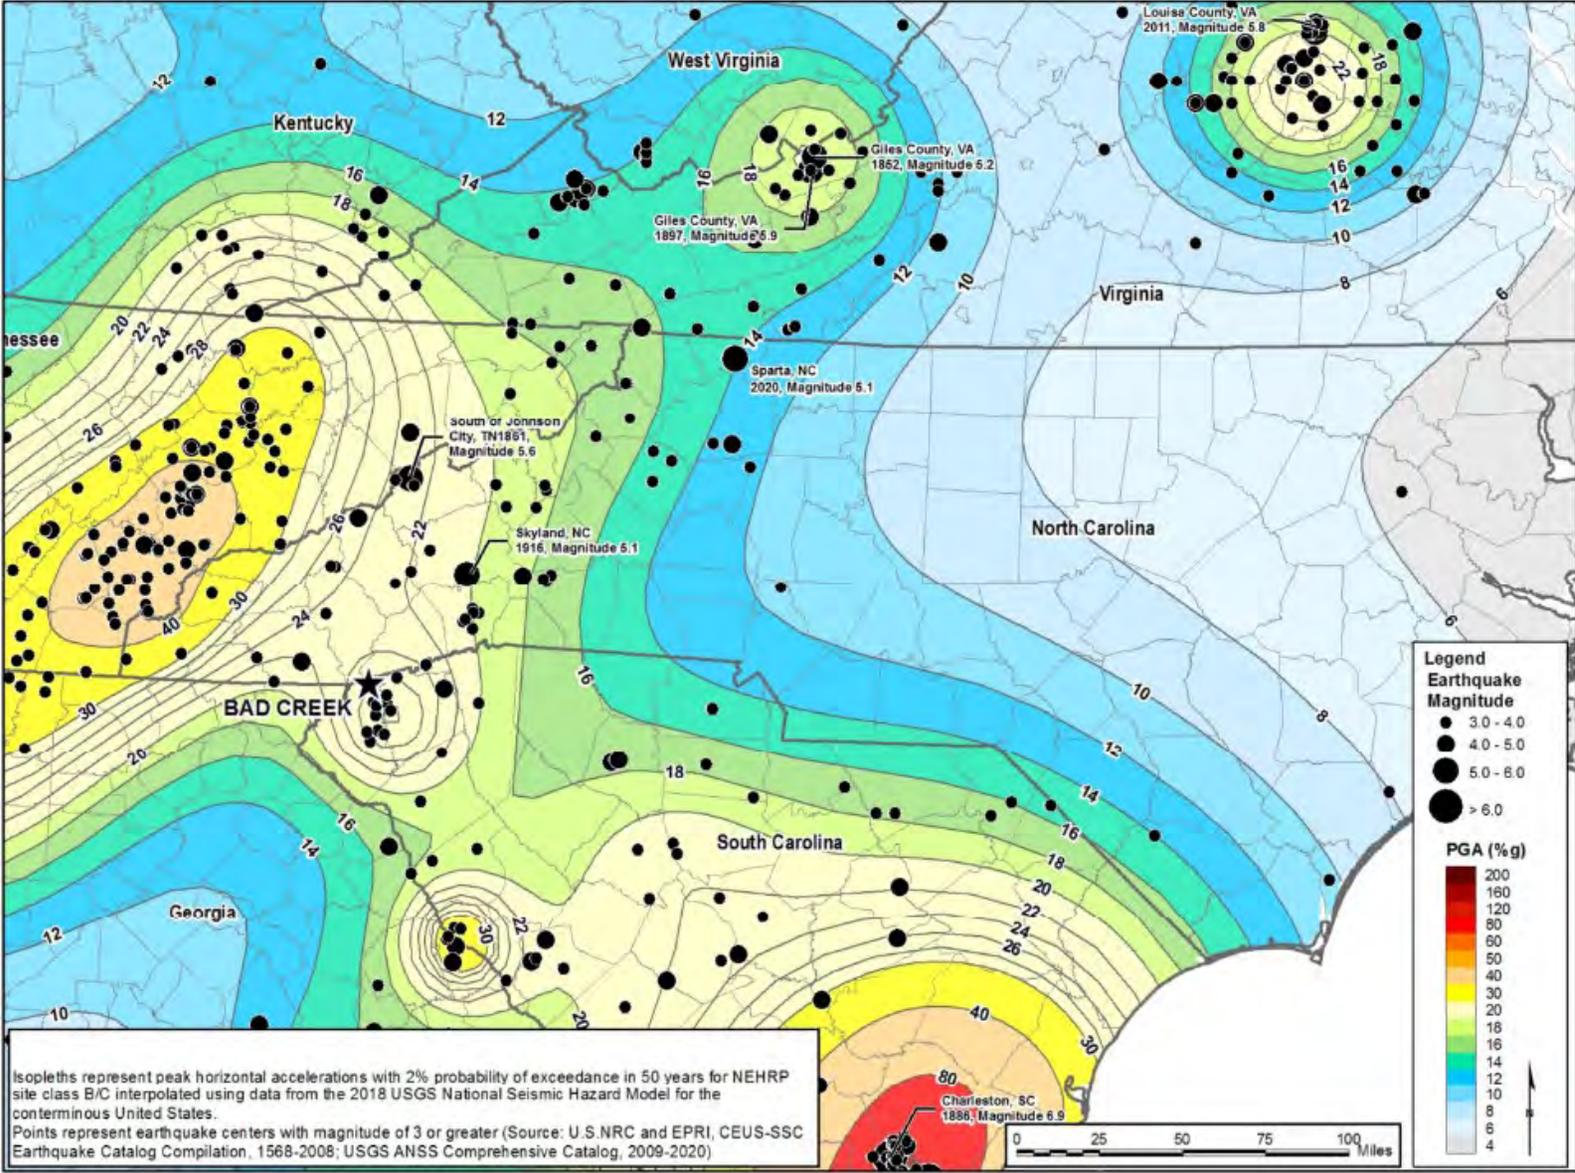
Figure 16. Seismic Hazard and Historic Earthquake Centers near the Bad Creek Pumped Storage Project

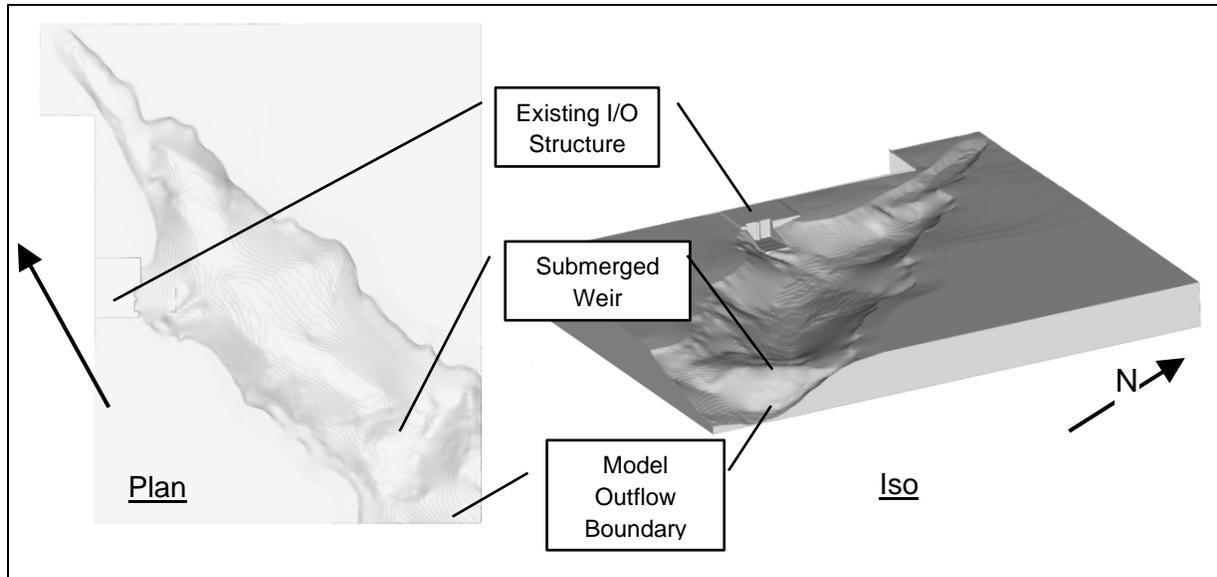
Figure 1. Existing I/O Structure and Lake Jocassee Bathymetry

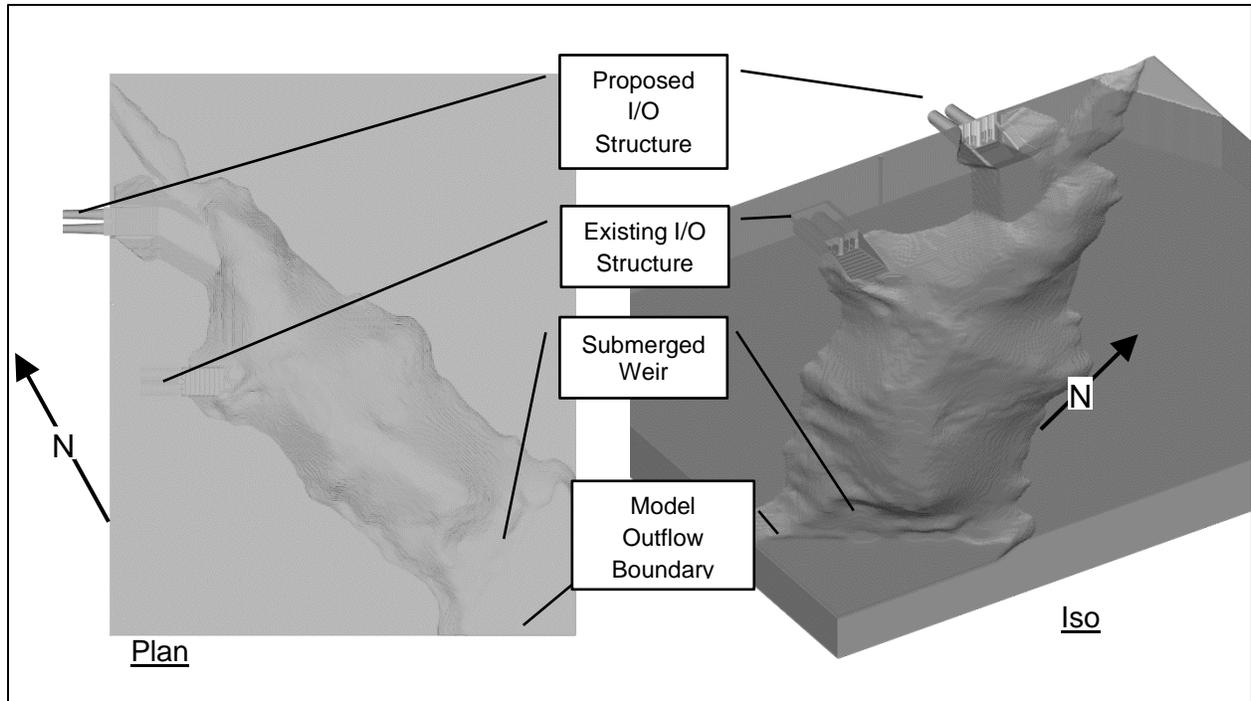
Figure 5. Existing and Proposed I/O Structure and Lake Jocassee Topography

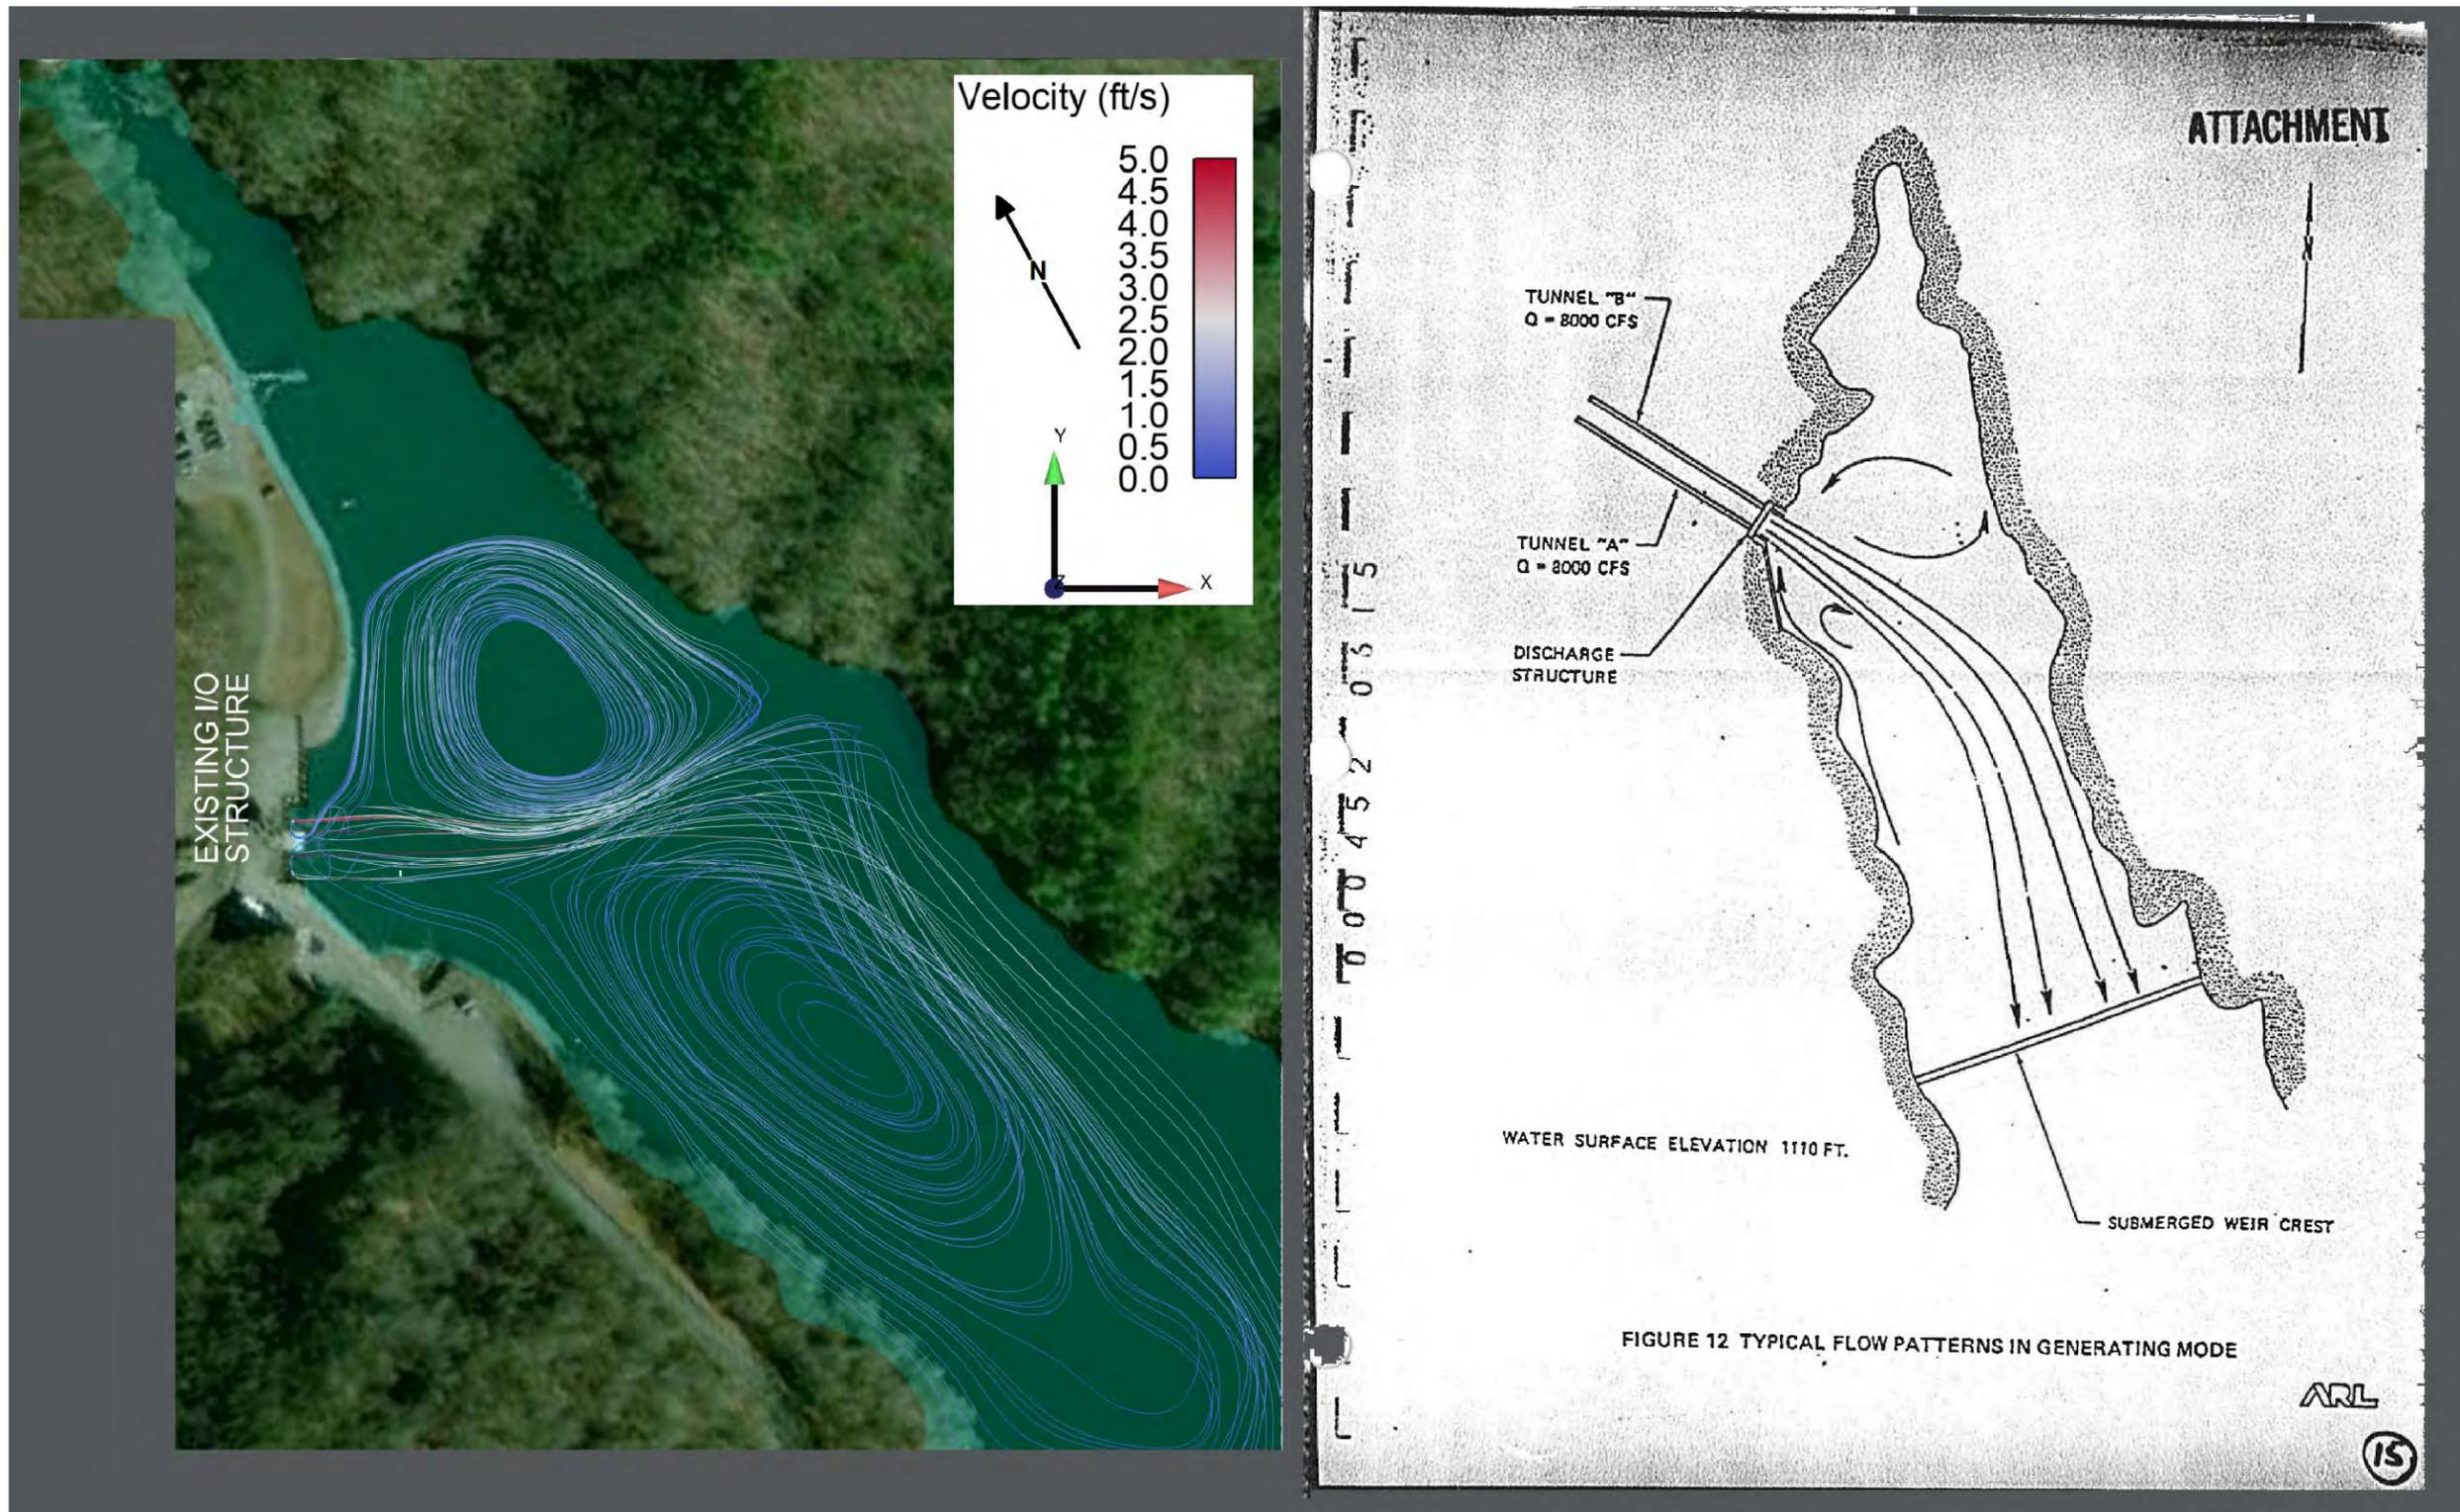
Figure 9. General Flow Pattern Comparison - CFD Model Case 1 Results vs ARL Physical Model Results - Lake Jocassee Normal Full Reservoir: 1,110 ft msl

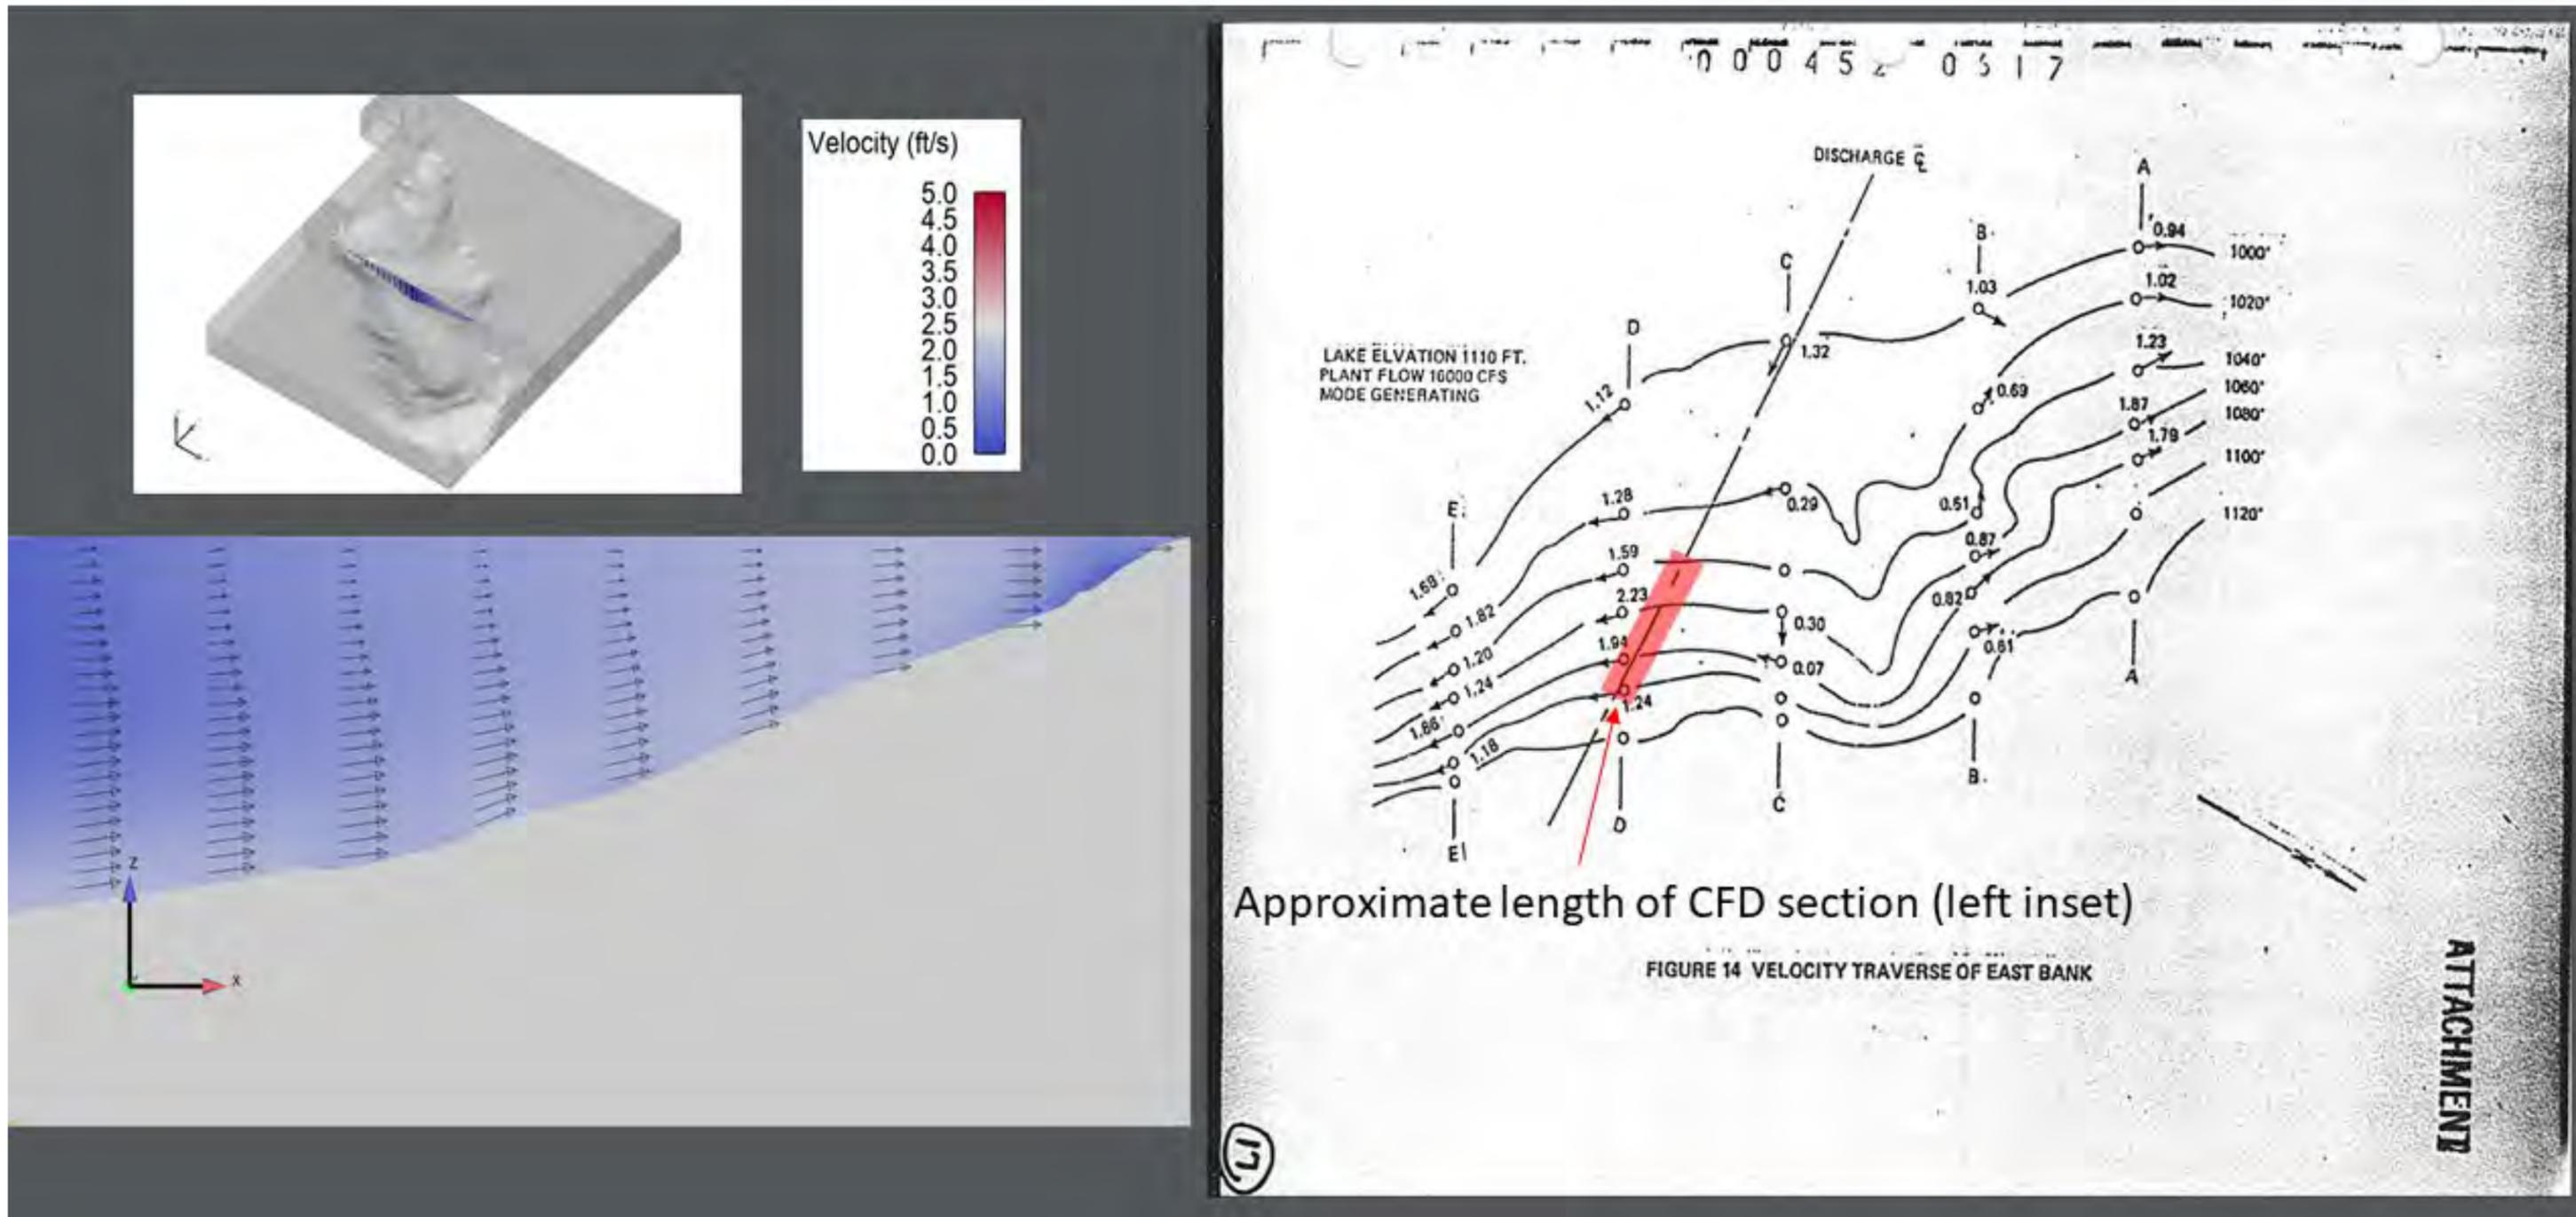
Figure 10. East Bank Velocity and Flow Pattern Comparison - CFD Model Case 1 Results vs ARL Physical Model Results - Lake Jocassee Normal Full Reservoir: 1,110 ft msl

The hydraulics for both the existing and proposed inlet/outlet structures were simulated to target outflow convergence to establish flow and velocity patterns along the east bank of the discharge area to assess potential for erosion. While the generation flow predicted by the physical model had higher velocities than that predicted by the CFD model, the overall flow patterns (including major recirculation patterns) were accurately captured in the CFD model. These observations are seen in both the full pond and maximum drawdown elevation scenarios for Lake Jocassee under existing conditions (16,000 cubic ft per second discharge). East bank velocities along the existing inlet/outlet structure centerline predicted by the physical model range between about 0.5 fps and 2.25 fps at reservoir level 1,110 ft msl. At the maximum drawdown reservoir elevation of 1,080 ft msl, the velocities are slightly lower ranging from 0.5 fps to 1.3 fps.

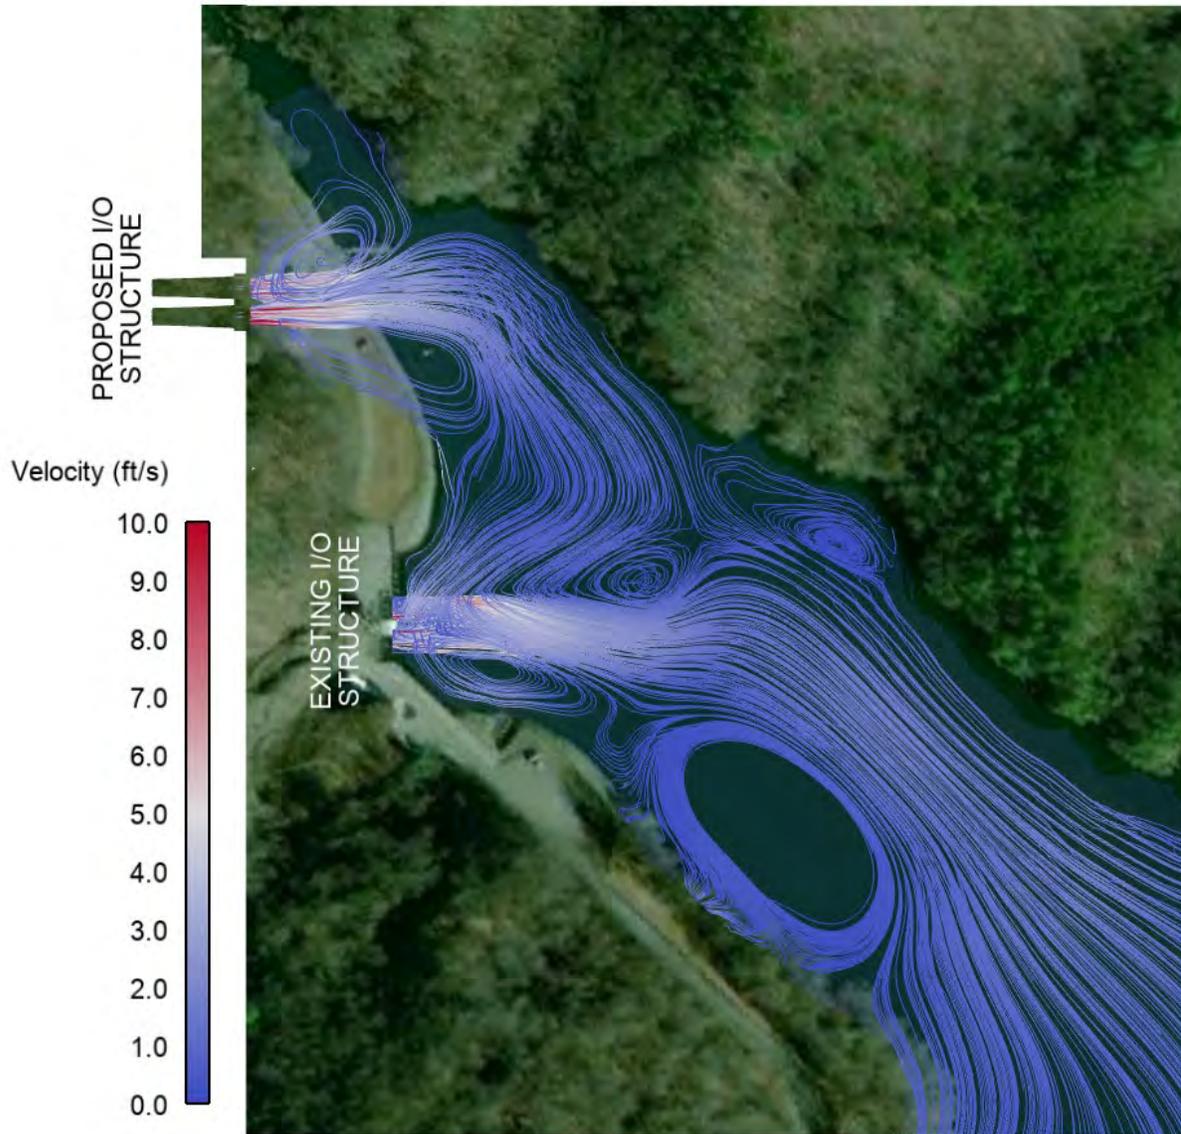
Figure 13. Case 3 (generation - maximum reservoir elevation) Velocity Streamlines at Normal Full Pool Elevation
