# Appendix D – Recreational Resources Draft Study Report

Bad Creek Pumped Storage Project

Foothills Trail Corridor  
Conditions Assessment  
Draft Report

# DRAFT FOOTHILLS TRAIL CORRIDOR CONDITIONS ASSESSMENT

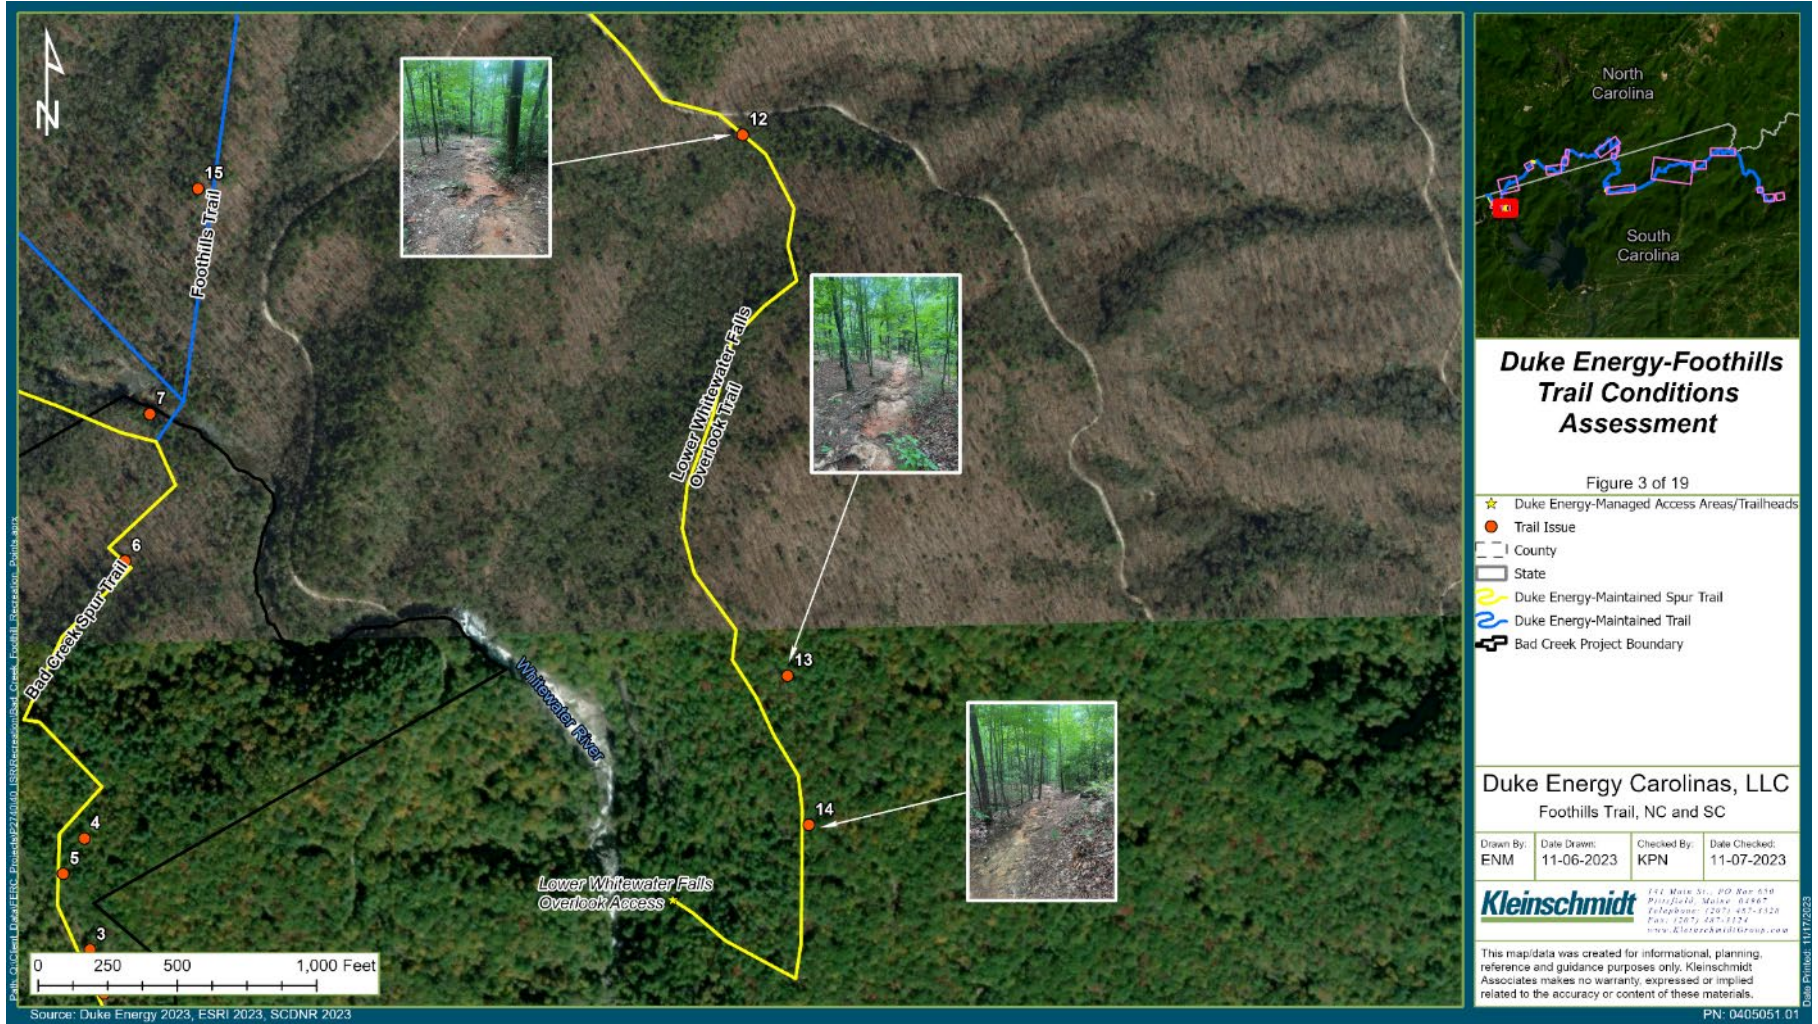
**Figure 4-5 Foothills Trail Conditions Assessment – Figure 4 of 19**

15	Figure 4-3	2023-09-14	Foothills Trail	31.6	35.02092083	-82.99665677	Washout	The trail needs some grade reversals or knicks. Water has gotten on the trail and does not leave for some time, causing a gully if not fixed.
16	Figure 4-5	2023-09-30	Foothills Trail	32.4	35.02958049	-82.99437631	Steps	Replace three steps

Trail Issue #	Figure #	Date Assessed	Trail Name	Mile Marker	Latitude	Longitude	Assessment Type	Description/Details
17	Figure 4-5	2023-09-30	Foothills Trail	33.3	35.03730923	-82.98769713	Steps	Replace three steps
18	Figure 4-5	2023-09-30	Foothills Trail	33.9	35.03812814	-82.98336354	Steps	One step needs to be replaced.
19	Figure 4-5	2023-09-30	Foothills Trail	34.2	35.03822699	-82.98165951	Steps	Steps need to be replaced.
20	Figure 4-6	2023-09-30	Foothills Trail	35.5	35.04768531	-82.96974848	Obstacle, Fallen Tree	Tree across trail and needs to be removed.
21	Figure 4-6	2023-09-18	Foothills Trail	35.8	35.05077596	-82.96808629	Steps	Two steps need to be replaced.
22	Figure 4-7	2023-09-30	Foothills Trail	37.2	35.04848663	-82.95255533	Steps	One step is rotten and needs to be replaced.
23	Figure 4-7	2023-09-30	Foothills Trail	37.3	35.04886479	-82.95224431	Obstacle, Other	From mile 36.2 at Hilliard Falls Trail to 37.3 at Bear camp campsite

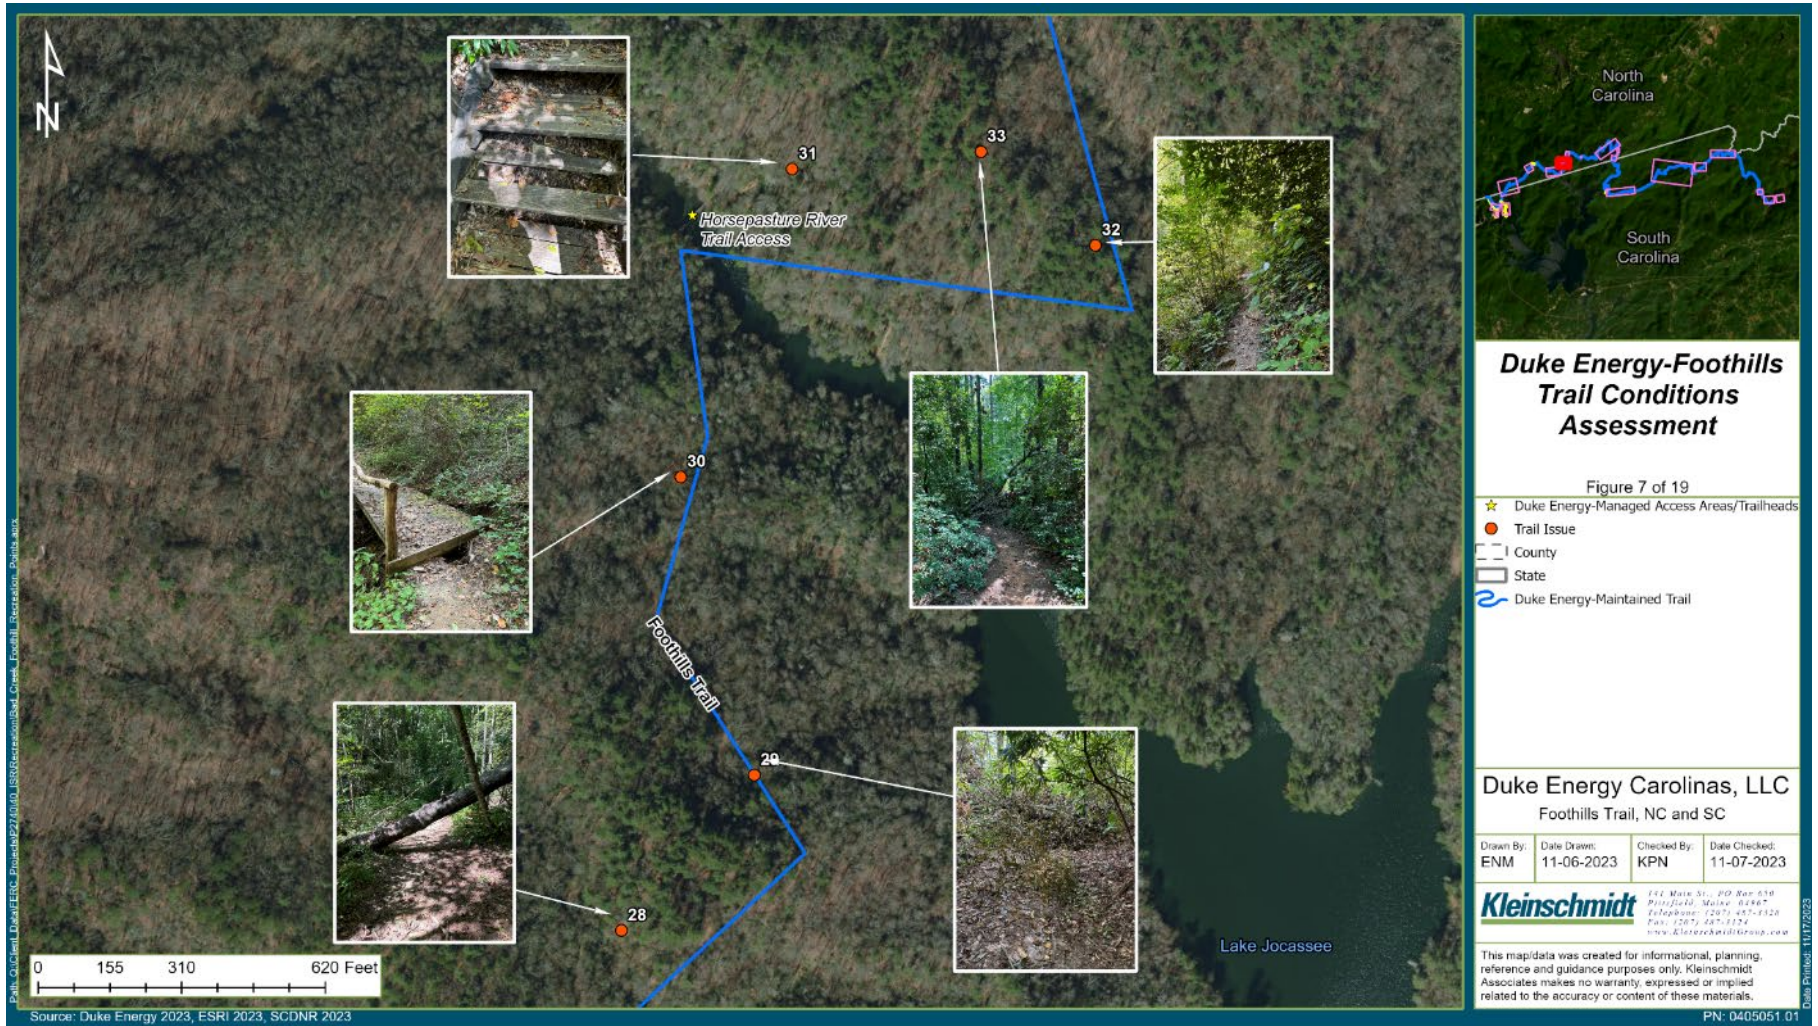
Figure 4-8 Foothills Trail Conditions Assessment – Figure 7 of 19

Trail Issue #	Figure #	Date Assessed	Trail Name	Mile Marker	Latitude	Longitude	Assessment Type	Description/Details
31	Figure 4-8	2023-10-01	Foothills Trail	39.9	35.05678279	-82.93638778	Steps	One step needs to be replaced
32	Figure 4-8	2023-10-01	Foothills Trail	40.1	35.05636493	-82.93419022	Obstacle, Other	Trail needs to be trimmed for 2/10 of a mile from Horse Pasture River Bridge to mile 40.3.
33	Figure 4-8	2023-10-01	Foothills Trail	40.2	35.05690722	-82.93502841	Obstacle, Fallen Tree	Tree removal
34	Figure 4-9	2023-10-01	Foothills Trail	40.4	35.05892556	-82.93459743	Obstacle, Fallen Tree	Tree removal
35	Figure 4-9	2023-10-01	Foothills Trail	40.4	35.05894665	-82.93456431	Obstacle, Fallen Tree	Tree removal
36	Figure 4-9	2023-10-01	Foothills Trail	40.5	35.05893904	-82.9342663	Bridge, Bridge	Trees falling on bridge needs to be repaired.
37	Figure 4-9	2023-10-01	Foothills Trail	40.5	35.05894956	-82.93423148	Obstacle, Fallen Tree	Tree removal

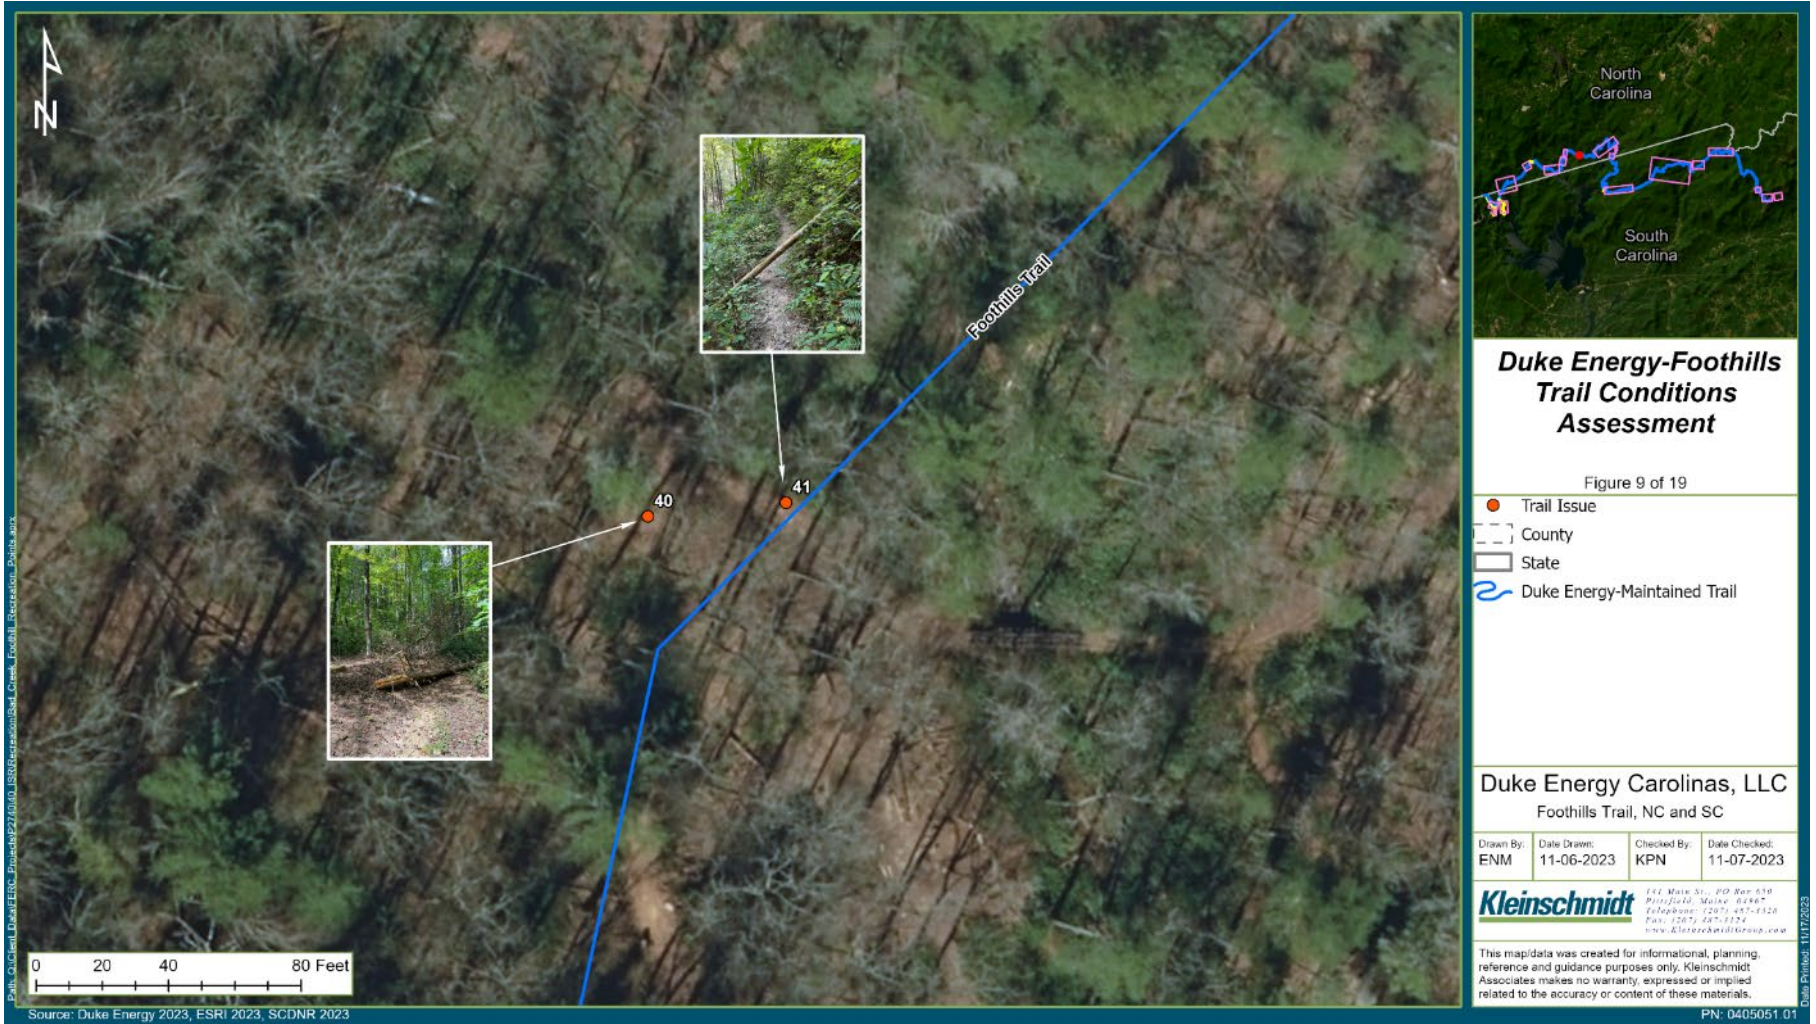
Figure 4-11 Foothills Trail Conditions Assessment – Figure 10 of 19

Trail Issue #	Figure #	Date Assessed	Trail Name	Mile Marker	Latitude	Longitude	Assessment Type	Description/Details
45	Figure 4-11	2023-10-01	Foothills Trail	48.3	35.07118731	-82.88726657	Obstacle, Fallen Tree	Tree needs to be removed from across trail.
46	Figure 4-12	2023-10-01	Foothills Trail	48.8	35.06624918	-82.8858863	Steps	Step replacement
47	Figure 4-12	2023-10-01	Foothills Trail	48.9	35.06471527	-82.88571508	Additional Comment	Bench needs to be replaced.
48	Figure 4-12	2023-10-01	Foothills Trail	48.9	35.06448911	-82.88557639	Bridge, Bog Bridges	Bog bridge needs to be added.
49	Figure 4-12	2023-10-01	Foothills Trail	48.9	35.06423394	-82.8852986	Steps	Two steps need to be replaced. They are missing. One step needs to be repaired.
50	Figure 4-13	2023-10-01	Foothills Trail	49.1	35.06204989	-82.88605607	Steps	One step needs to be replaced.
51	Figure 4-13	2023-10-01	Foothills Trail	49.2	35.06188881	-82.88646935	Obstacle, Fallen Tree	Tree across trail needs to be cut.

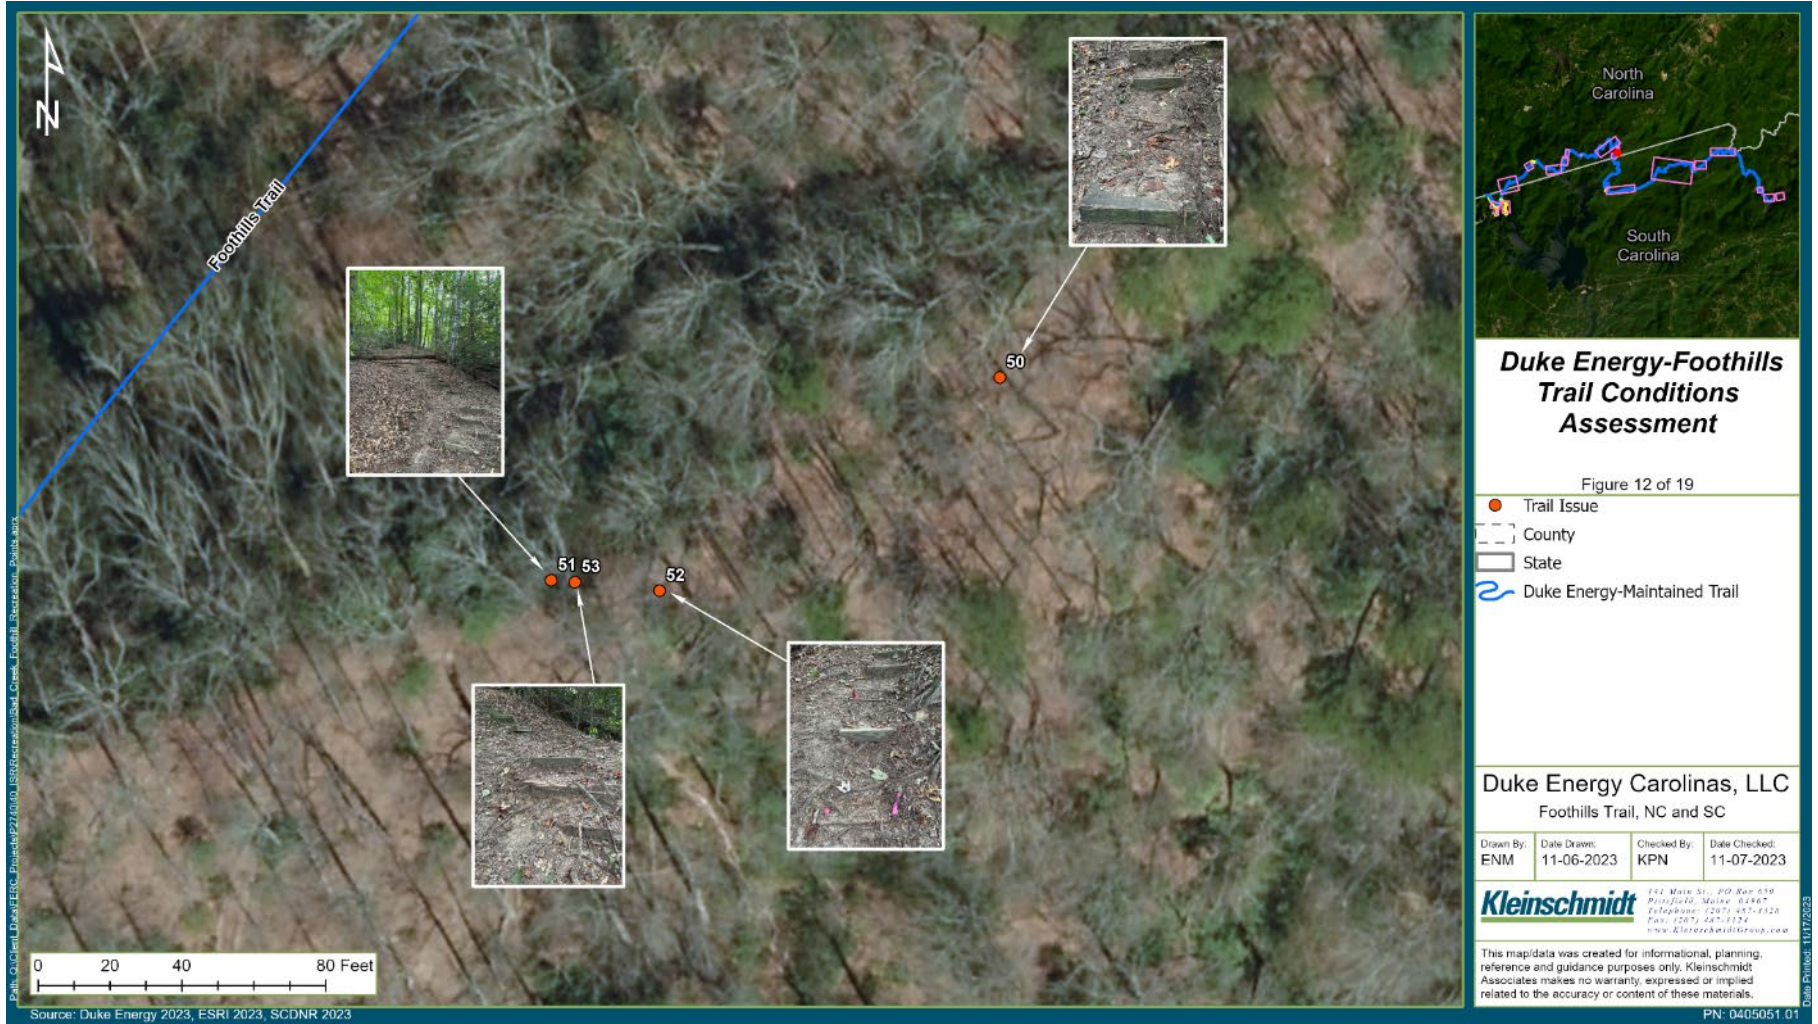
**Figure 4-13 Foothills Trail Conditions Assessment – Figure 12 of 19**

52	Figure 4-13	2023-10-01	Foothills Trail	49.2	35.06188238	-82.88636861	Steps	Two steps are missing and need to be replaced.
53	Figure 4-13	2023-10-01	Foothills Trail	49.2	35.06188773	-82.88644732	Steps	One step needs to be replaced.
54	Figure 4-14	2023-10-01	Foothills Trail	49.4	35.06033756	-82.88994145	Steps	One step needs to be replaced.
55	Figure 4-14	2023-10-01	Foothills Trail	49.5	35.06031437	-82.88911736	Steps	One step needs to be replaced.
56	Figure 4-14	2023-10-01	Foothills Trail	49.9	35.05836929	-82.89148322	Obstacle, Fallen Tree	Tree across trail needs to be cut.
57	Figure 4-15	2023-09-17	Foothills Trail	53.9	35.03336423	-82.8943042	Obstacle, Fallen Tree	Tree has fallen across trail and holding back water, causing erosion before the tree fall.
58	Figure 4-15	2023-09-17	Foothills Trail	54.2	35.03126431	-82.89076147	Culvert, Open Drain	Culvert has collapsed and needs replacing

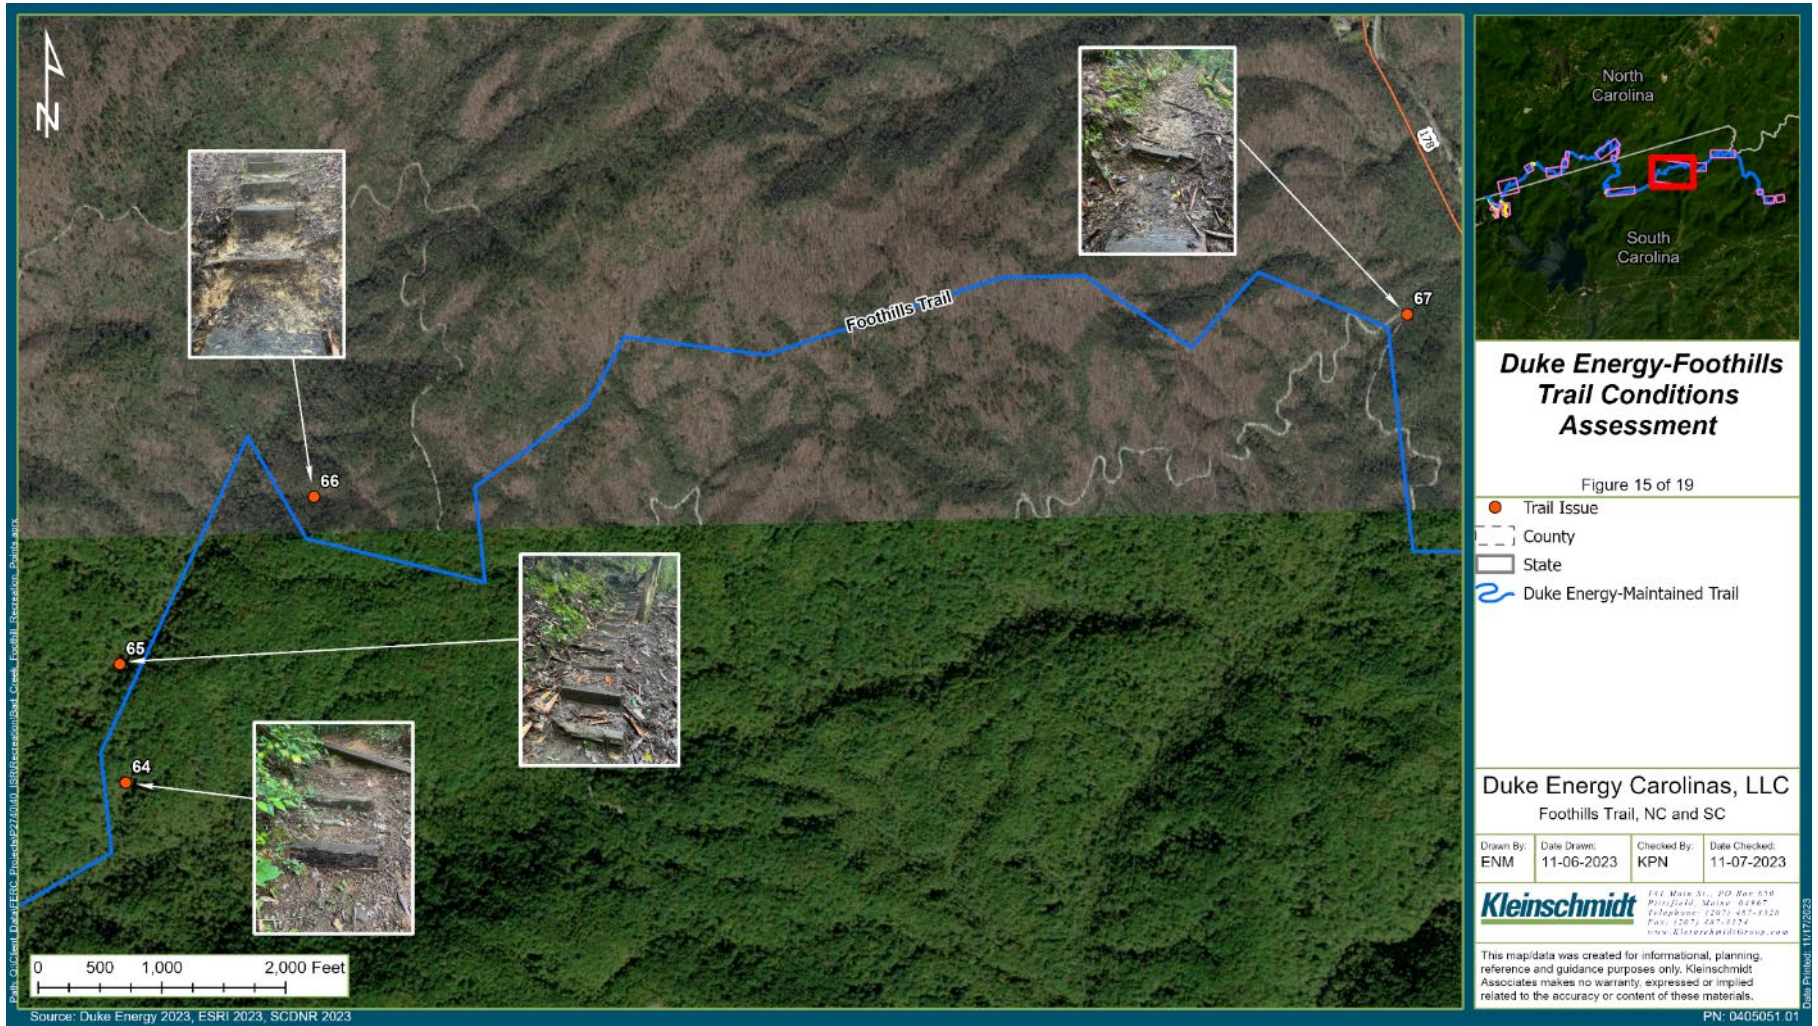
Figure 4-16 Foothills Trail Conditions Assessment – Figure 15 of 19

64	Figure 4-16	2023-09-17	Foothills Trail	57.1	35.04325018	-82.85098593	Steps	Two steps are rotten and need to be replaced.
65	Figure 4-16	2023-09-17	Foothills Trail	57.3	35.04586891	-82.85120517	Steps	4 steps need to be replaced.
66	Figure 4-16	2023-09-17	Foothills Trail	57.9	35.04966325	-82.84604181	Steps	One step needs to be replaced.
67	Figure 4-16	2023-09-17	Foothills Trail	61.2	35.054138	-82.8166194	Steps	One step needs to be replaced.
68	Figure 4-17	2023-07-16	Foothills Trail	62	35.05087322	-82.81288696	Bridge, Bridge	One 2x6x12 bore needs to be replaced. It is rotten.
69	Figure 4-17	2023-07-16	Foothills Trail	62	35.05092472	-82.81235406	Steps	Rotten. Needs to be replaced.
70	Figure 4-17	2023-07-16	Foothills Trail	62.1	35.05166502	-82.81183115	Steps	Needs to be replaced. Rotten.

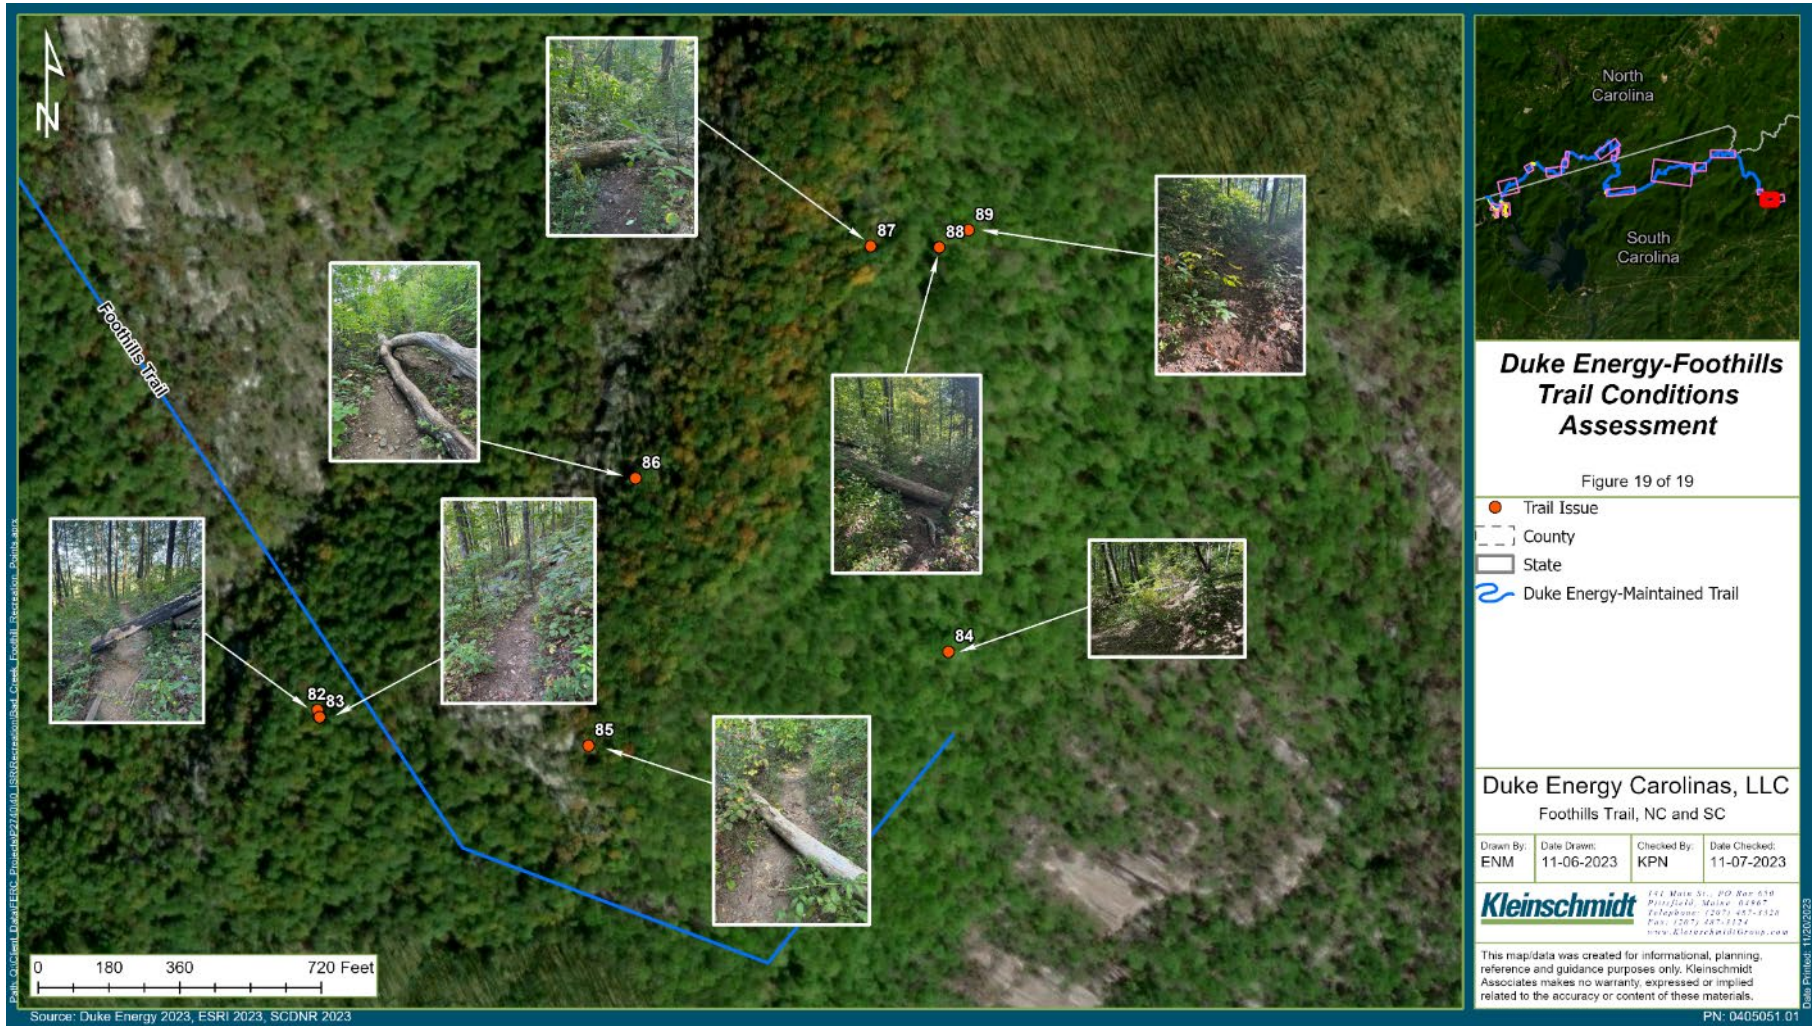
Figure 4-20 Foothills Trail Conditions Assessment – Figure 19 of 19

89	Figure 4-20	2023-10-02	Foothills Trail	71.9	35.0316208	-82.74135269	Obstacle, Other	Corridor needs to be cleared and brushed removed from mile 70.9 at Lighthouse Campsite to 72.1 at Pinnacle Mountain Trail Junction.

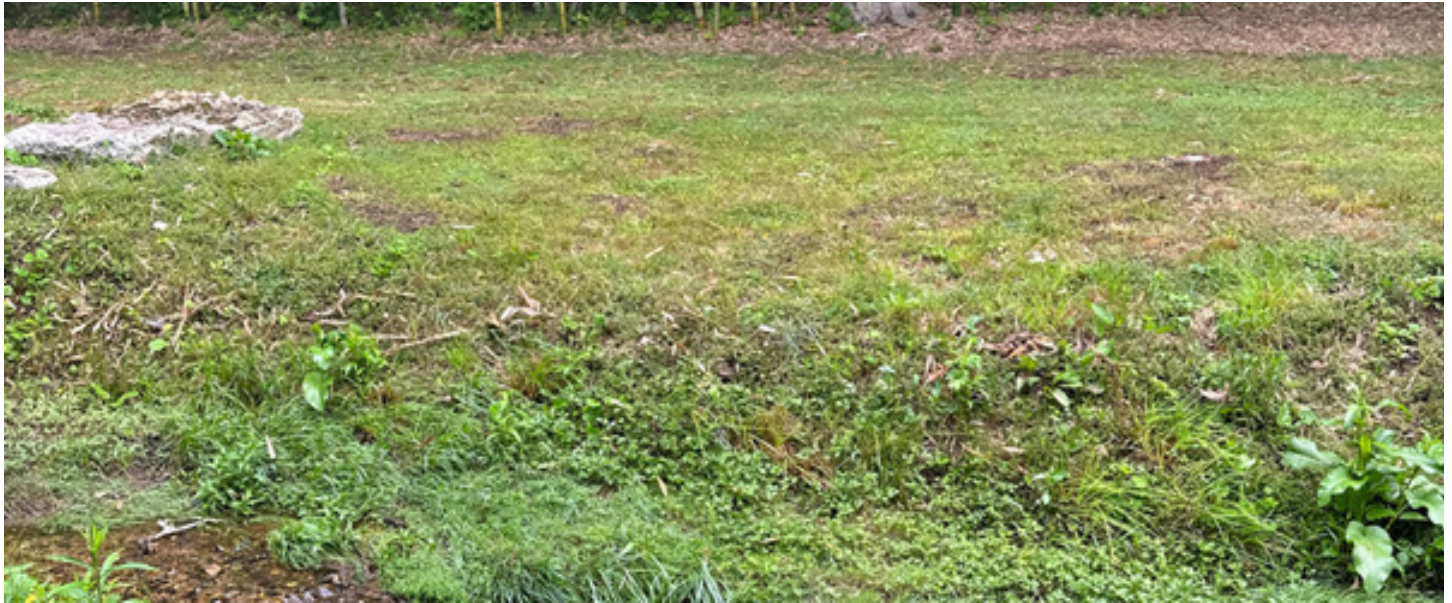
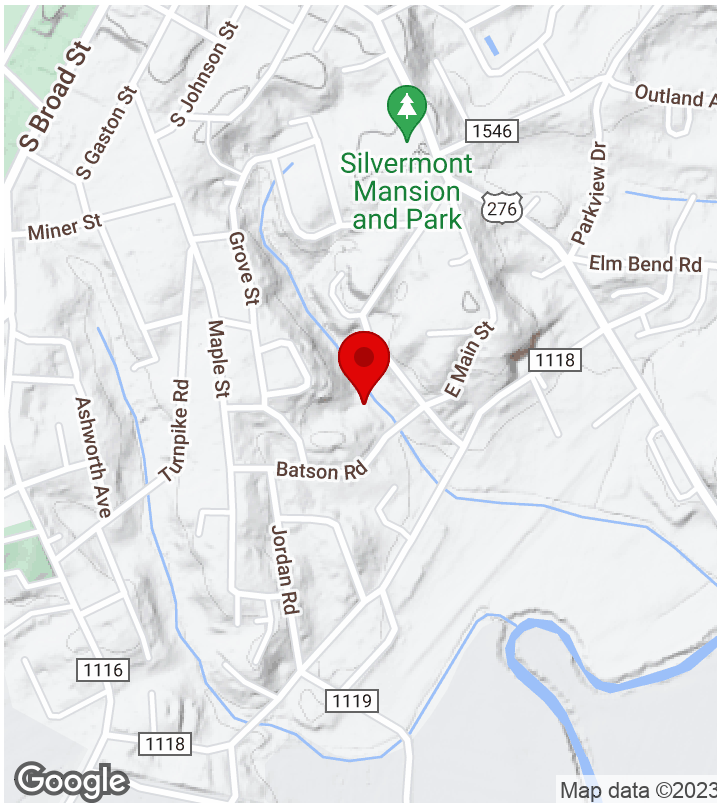
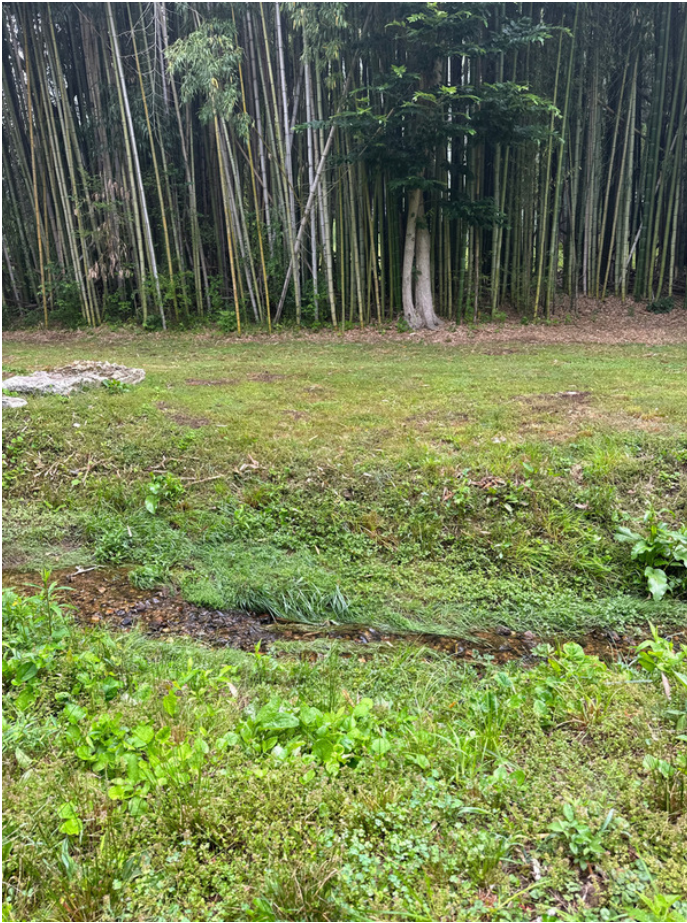
## Bad Creek Access Spur, 12, Bridge ► Bridge, 30' L x 5' W x 2' H

<b>Date</b>	June 17, 2023
<b>Trail Name</b>	Bad Creek Access Spur
<b>Assessment's Name</b>	
<b>Mile Marker</b>	12
<b>Assessment Type</b>	Bridge ► Bridge
<b>Measurements</b>	30' L x 5' W x 2' H
<b>Description / Details / Comments</b>	Wooden Bridge with handrails on both sides. Needs new bridge - old one completely gone

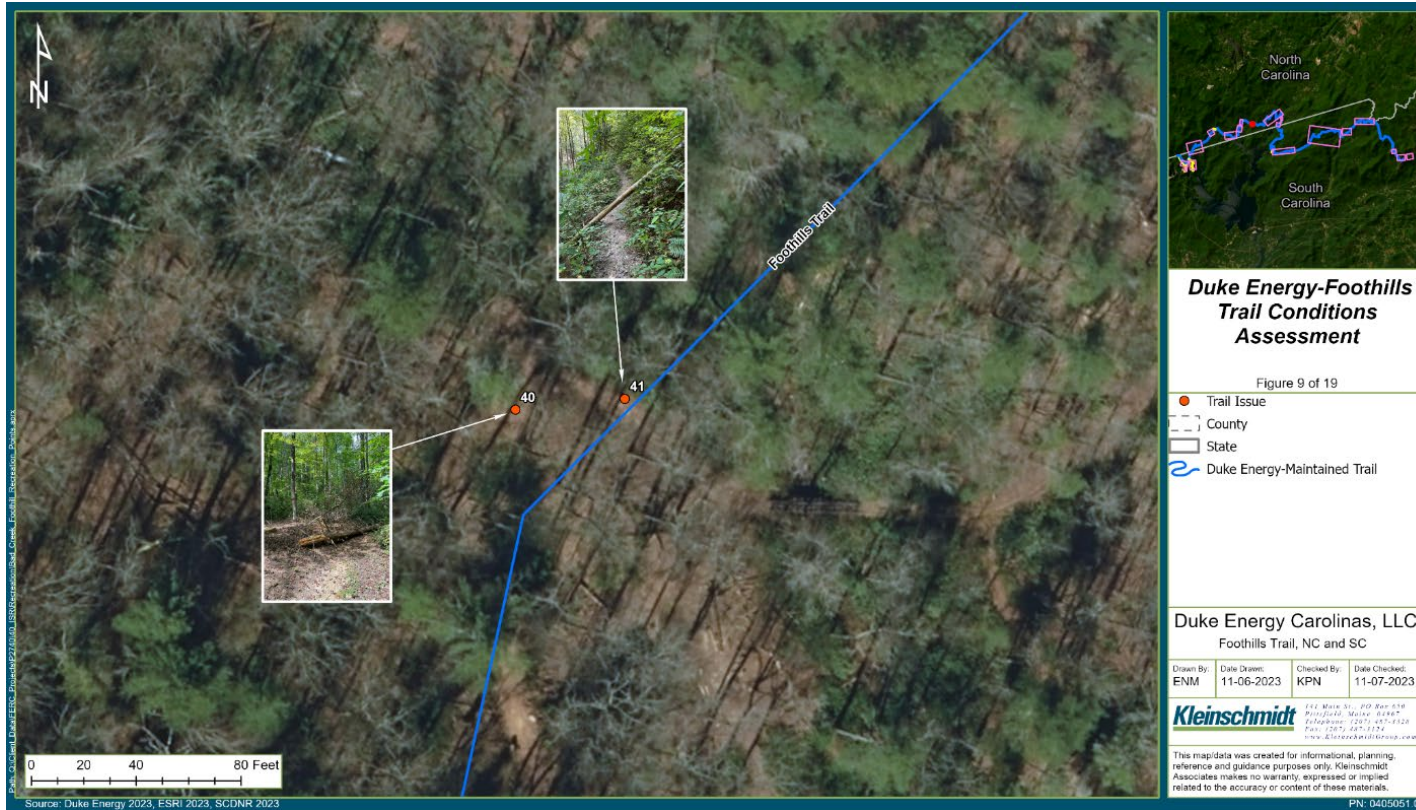
Figure 4-10 Foothills Trail Conditions Assessment – Figure 9 of 19

38	Figure 4-9	2023-10-01	Foothills Trail	40.8	35.06270942	-82.93295438	Obstacle, Fallen Tree	Tree needs to be removed.
39	Figure 4-9	2023-10-01	Foothills Trail	40.9	35.06302301	-82.93270134	Washout	15 feet of trail needs to be re-benched.
40	Figure 4-10	2023-10-01	Foothills Trail	42.6	35.05953224	-82.92052046	Obstacle, Fallen Tree	Fallen tree needs to be removed.
41	Figure 4-10	2023-10-01	Foothills Trail	42.6	35.05954586	-82.92038139	Obstacle, Fallen Tree	Tree removal
42	Figure 4-11	2023-10-01	Foothills Trail	44.6	35.06174146	-82.90542222	Obstacle, Fallen Tree	Fallen tree needs to be cut out.
43	Figure 4-11	2023-10-01	Foothills Trail	45.7	35.06475517	-82.90024767	Obstacle, Fallen Tree	Tree removal
44	Figure 4-11	2023-10-01	Foothills Trail	47.9	35.06632757	-82.88963219	Bridge, Bog Bridges	Bog bridge needs to be installed.

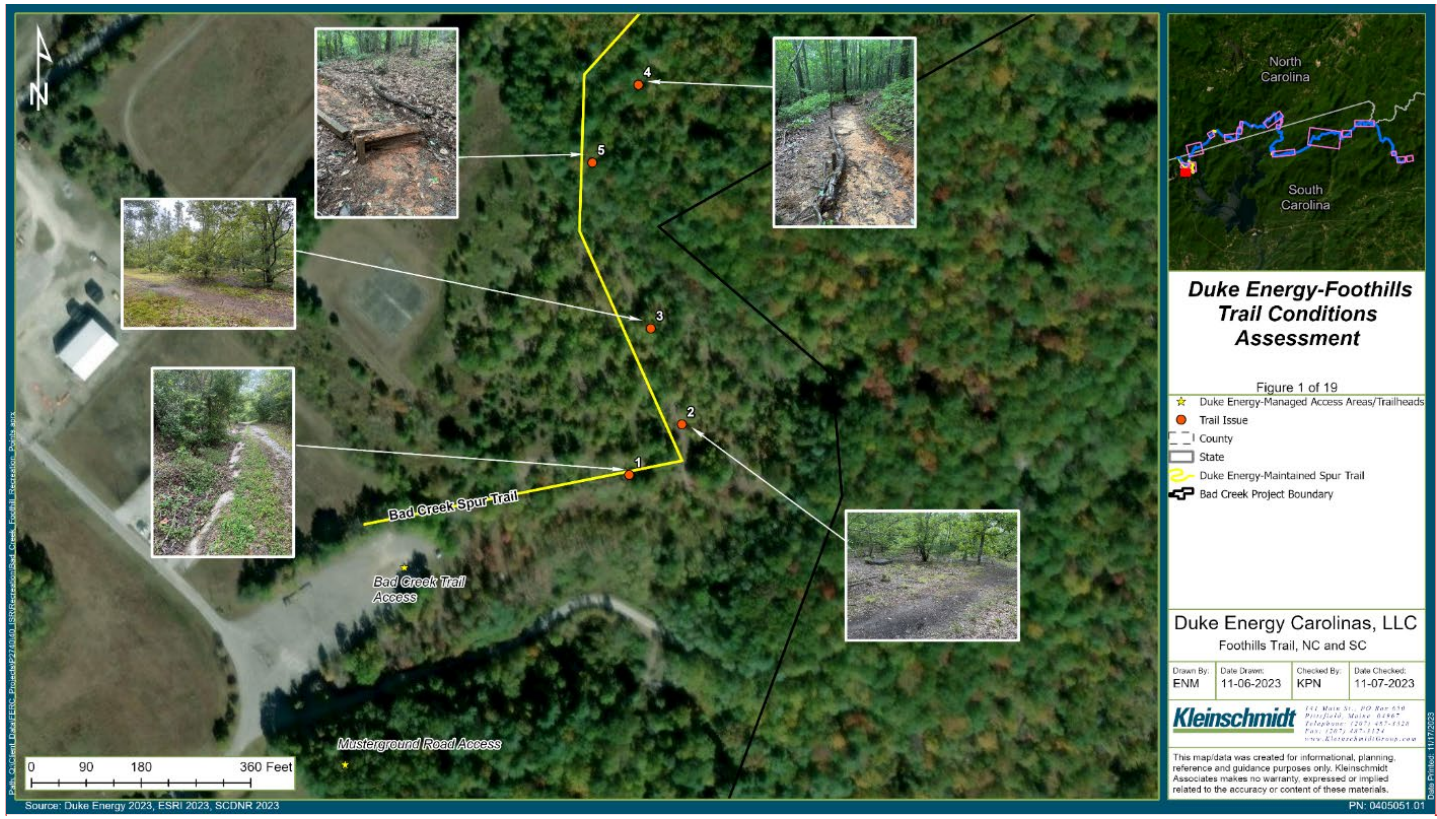
Figure 4-2 Foothills Trail Conditions Assessment – Figure 1 of 19

Commented [EM2]: Photo of Trail Issue #1 does not show the clogged culvert or downstream effects.

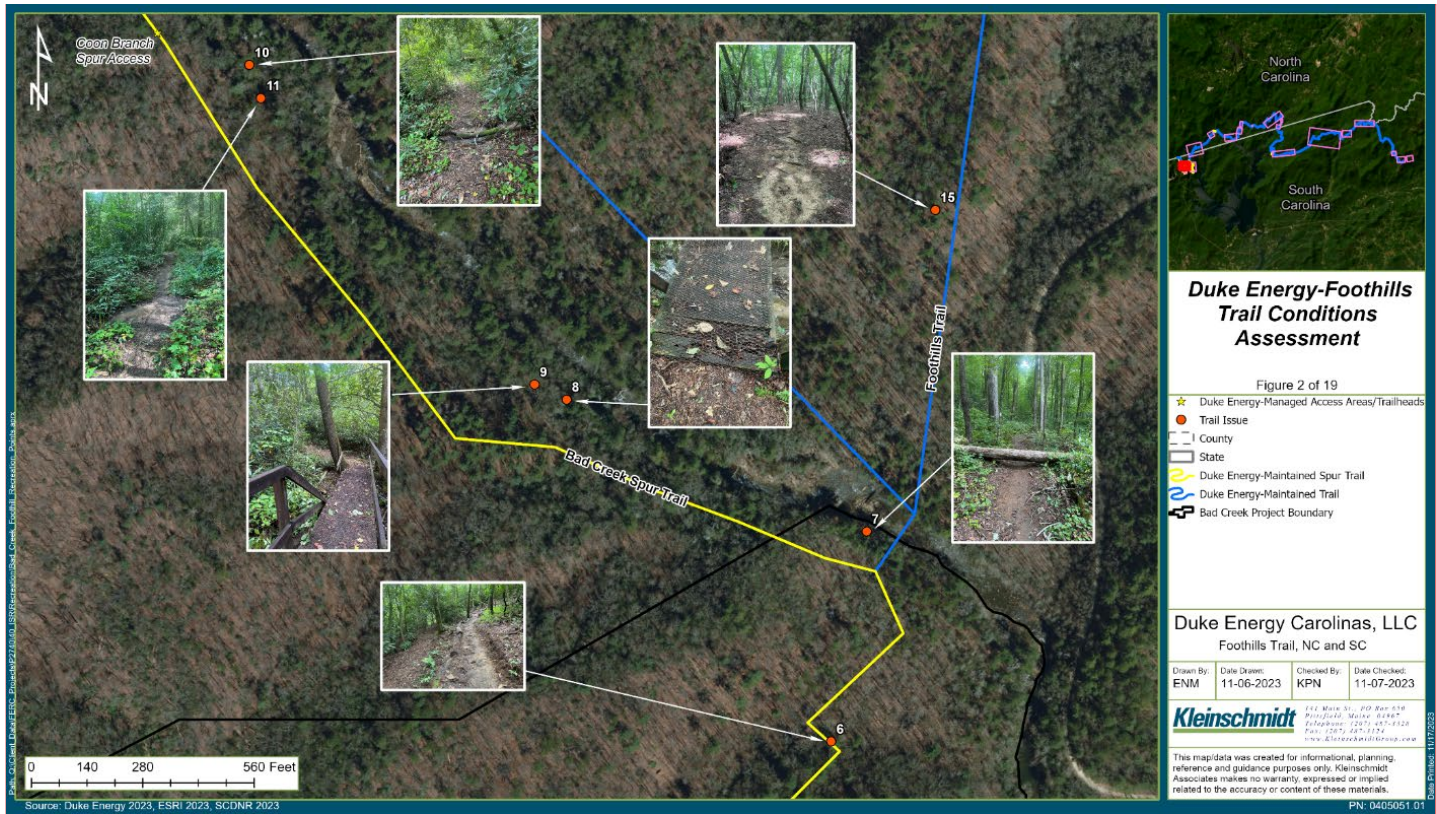
Figure 4-3 Foothills Trail Conditions Assessment – Figure 2 of 19

Commented [EM3]: Photo of Trail Issue #11 does not show the clogged culvert or downstream effects.

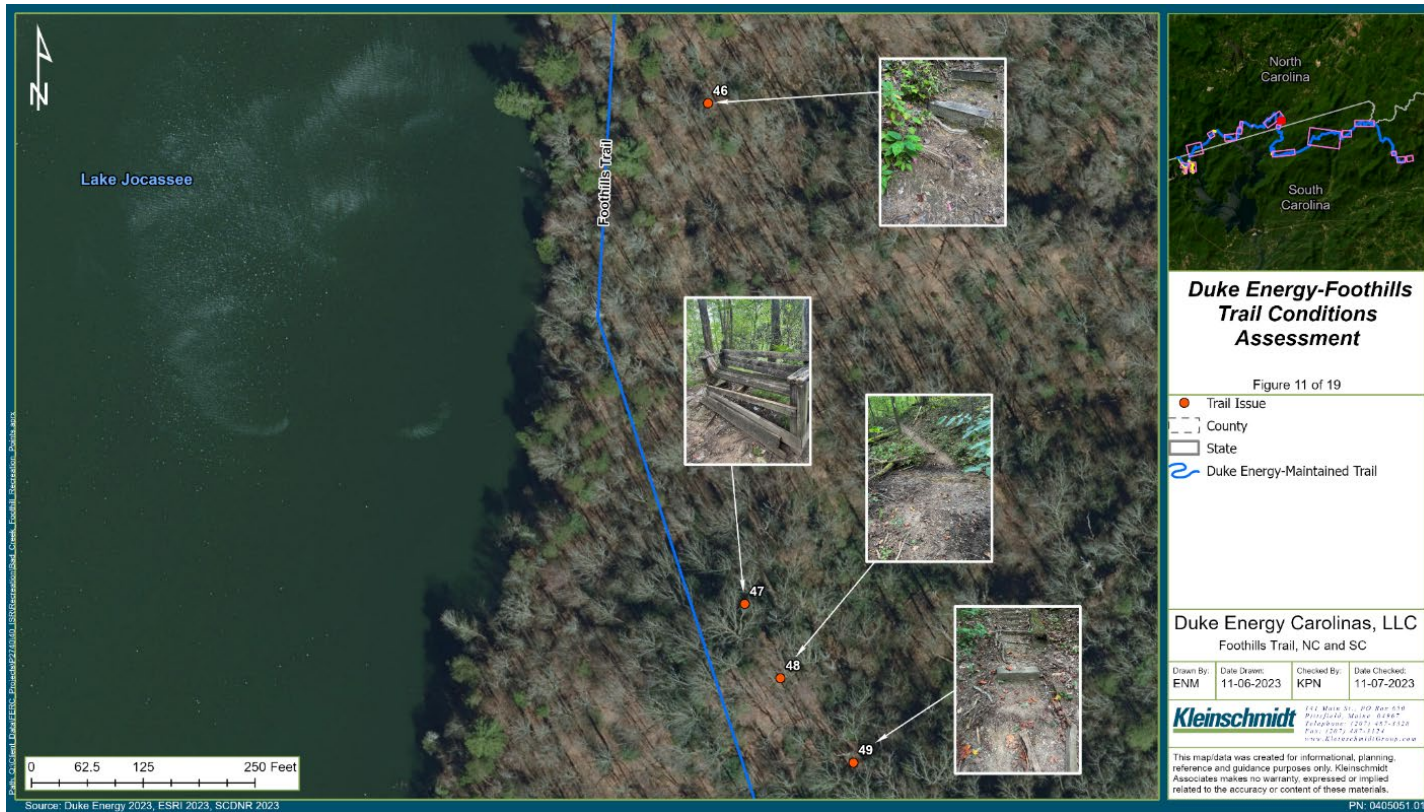
Figure 4-12 Foothills Trail Conditions Assessment – Figure 11 of 19

48	Figure 4-12	2023-10-01	Foothills Trail	<del>48.9</del> <a href="#">48.8</a>	<del>35.0663735</del> <a href="#">35.06448911</a>	<del>-82.88584</del> <a href="#">82.88557639</a>	Bridge, Bog Bridges	Bog bridge needs to be added.
49	Figure 4-12	2023-10-01	Foothills Trail	48.9	35.06423394	-82.8852986	Steps	Two steps need to be replaced. They are missing. One step needs to be repaired.

Trail Issue #	Figure #	Date Assessed	Trail Name	Mile Marker	Latitude	Longitude	Assessment Type	Description/Details
45	Figure 4-11	2023-10-01	Foothills Trail	48.3	35.07118731	-82.88726657	Obstacle, Fallen Tree	Tree needs to be removed from across trail.
46	Figure 4-12	2023-10-01	Foothills Trail	48.8	35.06624918	-82.8858863	Steps	Step replacement
47	Figure 4-12	2023-10-01	Foothills Trail	48.9	35.06471527	-82.88571508	Additional Comment	Bench needs to be replaced.
48	Figure 4-12	2023-10-01	Foothills Trail	48.9	35.06448911	-82.88557639	Bridge, Bog Bridges	Bog bridge needs to be added.
49	Figure 4-12	2023-10-01	Foothills Trail	48.9	35.06423394	-82.8852986	Steps	Two steps need to be replaced. They are missing. One step needs to be repaired.
50	Figure 4-13	2023-10-01	Foothills Trail	49.1	35.06204989	-82.88605607	Steps	One step needs to be replaced.
51	Figure 4-13	2023-10-01	Foothills Trail	49.2	35.06188881	-82.88646935	Obstacle, Fallen Tree	Tree across trail needs to be cut.
